**1899 COCHRANE STREET**

**SAANICH, BC**

**CONSTRUCTION IMPACT ASSESSMENT**

**TREE MANAGEMENT PLAN**

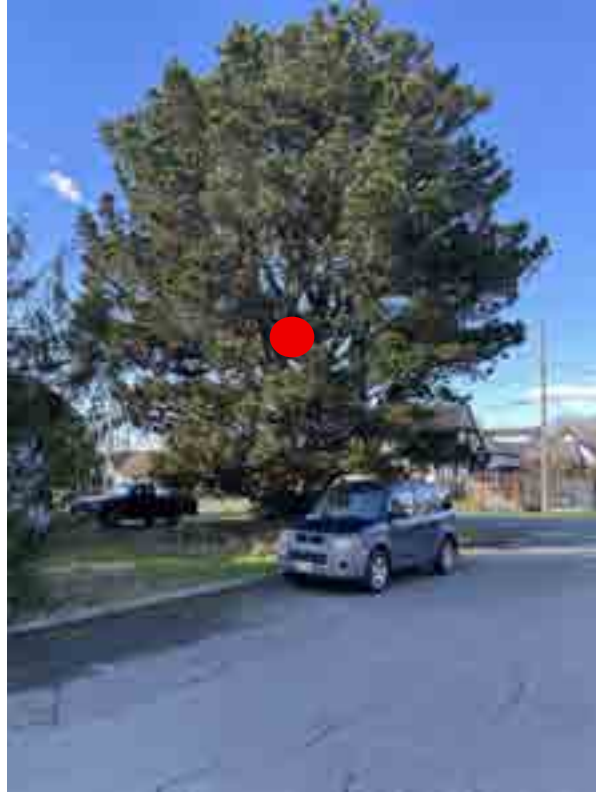
**Image 1:** Tree 2249 (red dot). Proposed as Retain\*

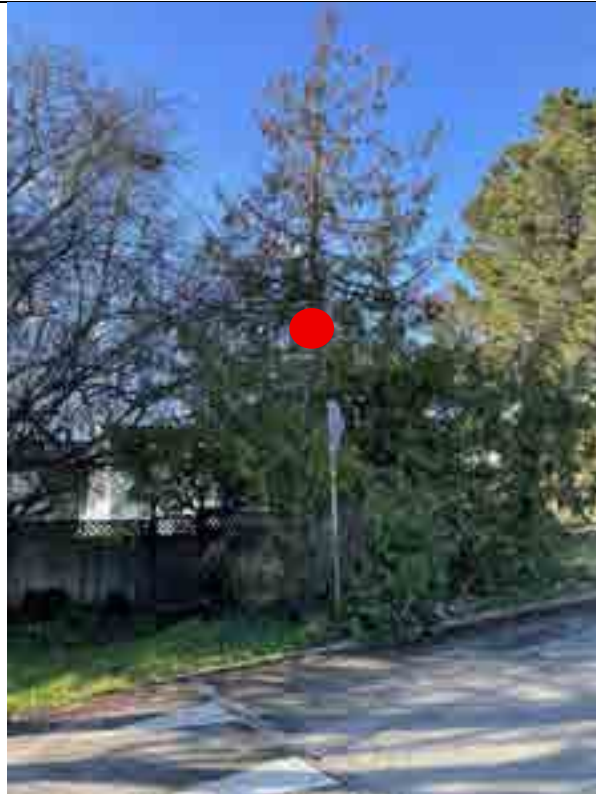
**Image 2:** Tree 2250 (red dot). Selected for removal.

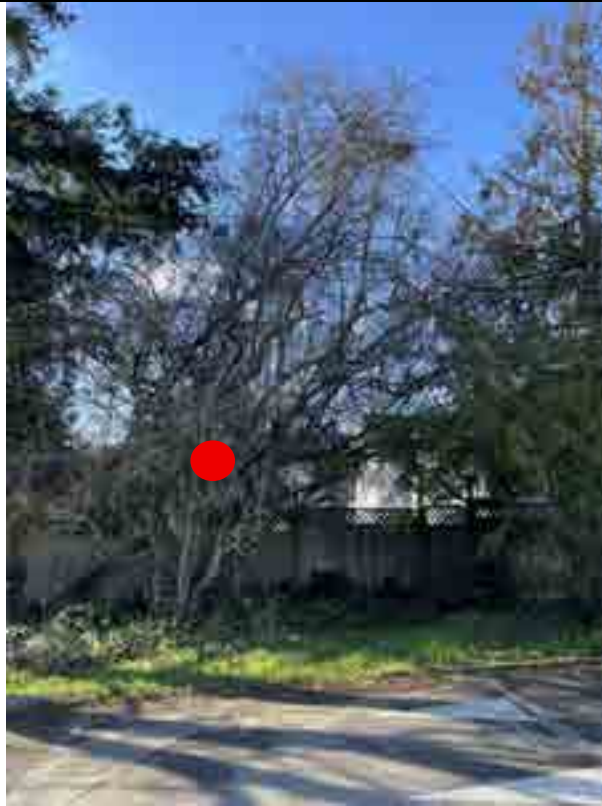
**Image 3:** Tree 2251 (red dot). Selected for removal.

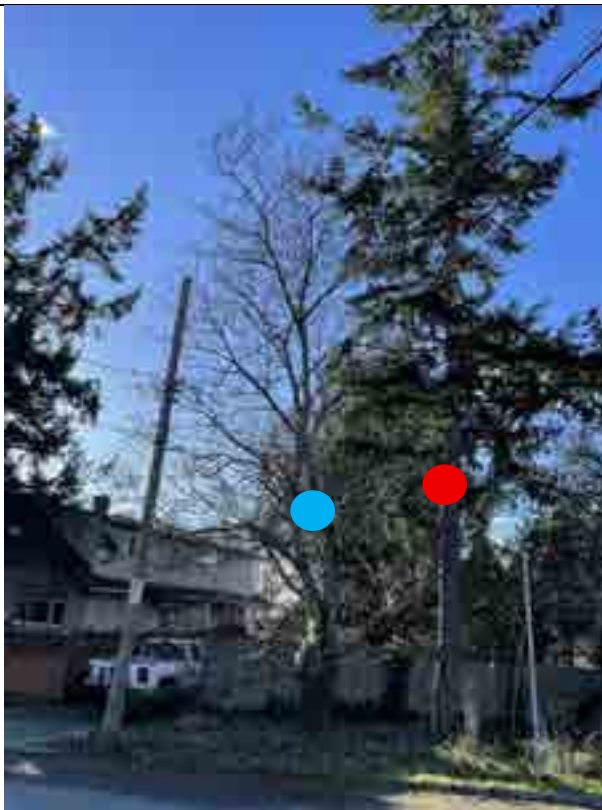
**Image 4:** Trees 2252 (red dot) & 2253 (blue dot). Both proposed as Retain\*

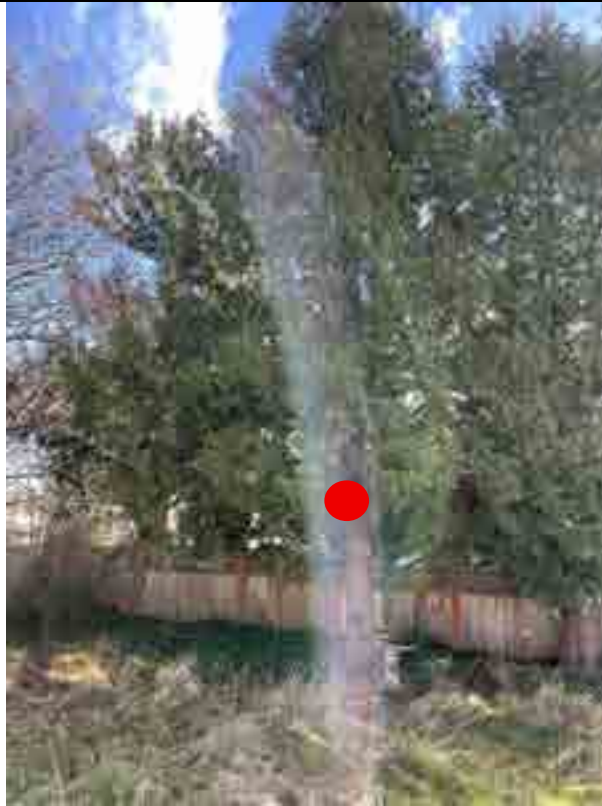
**Image 5:** Tree 2254 (red dot). Proposed for removal.

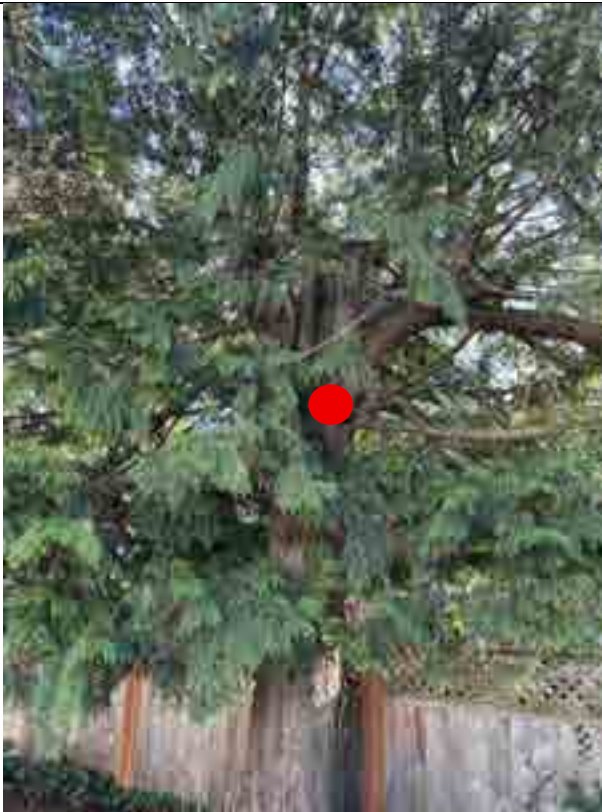
**Image 6:** Tree 2255 (red dot). Proposed for removal.

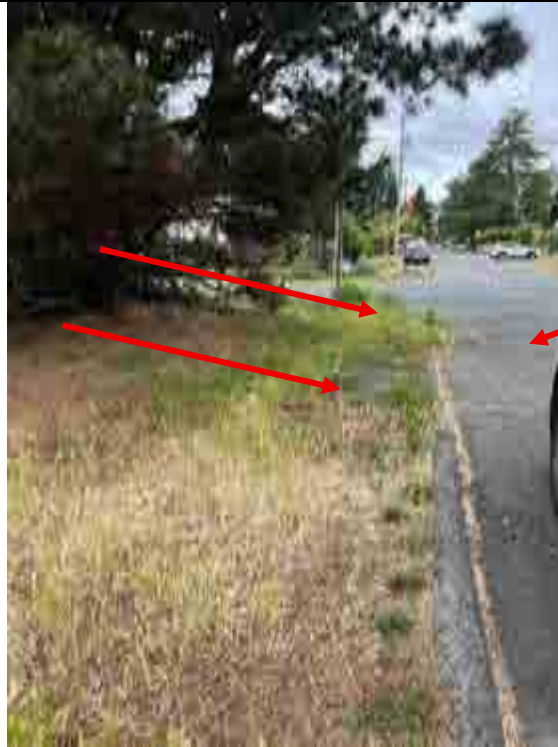
**Image 7:** To our understanding the proposed back of sidewalk (wooden stake) and curb (pink line), on the east side of tree 2249 (Dean Avenue) were surveyed. See red arrows.

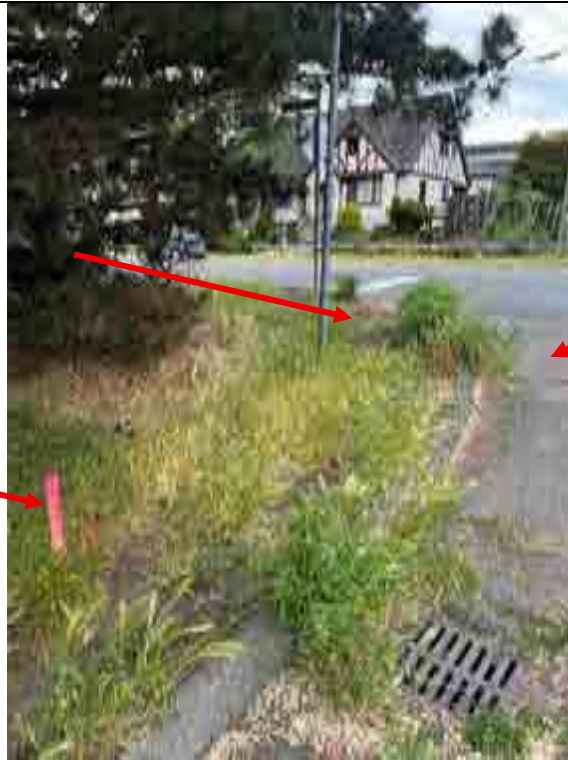
**Image 8:** To our understanding the Proposed back of sidewalk (wooden stake) and curb (pink line), on the east side of tree 2249 (Dean Avenue) were surveyed. See red arrows.

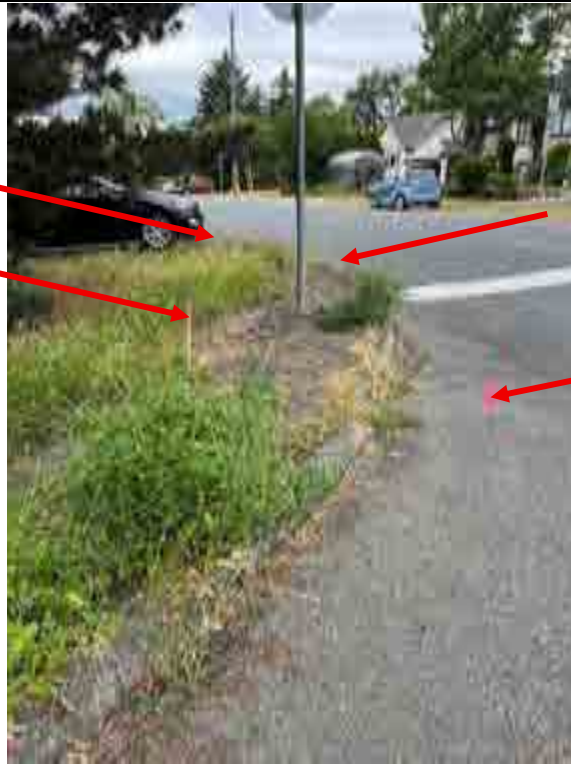
**Image 9:** To our understanding the Proposed back of sidewalk (wooden stake) and curb (pink line), on the northeast of tree 2249 (corner of Cochrane Road and Dean Avenue) were surveyed. See red arrows.

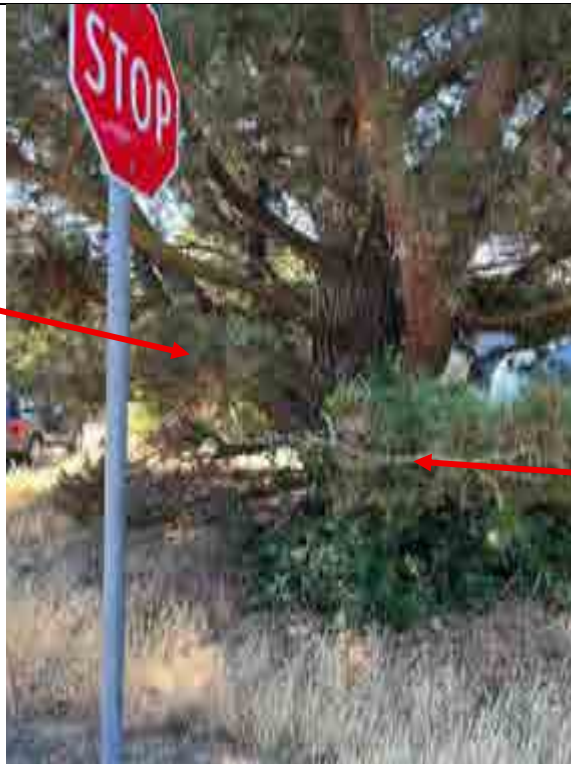
**Image 10:** North side of tree 2249. Branches likely requiring removal for sidewalk clearance (red arrows). The project arborist should be on-site to coordinate and clarify what branches need to be pruned.

All pruning is to be done by an ISA certified Arborist and done to the industries best current management practices. It is recommended that the project arborist be on-site during the pruning to ensure the proper branches are removed. See **Appendix A, T1**.

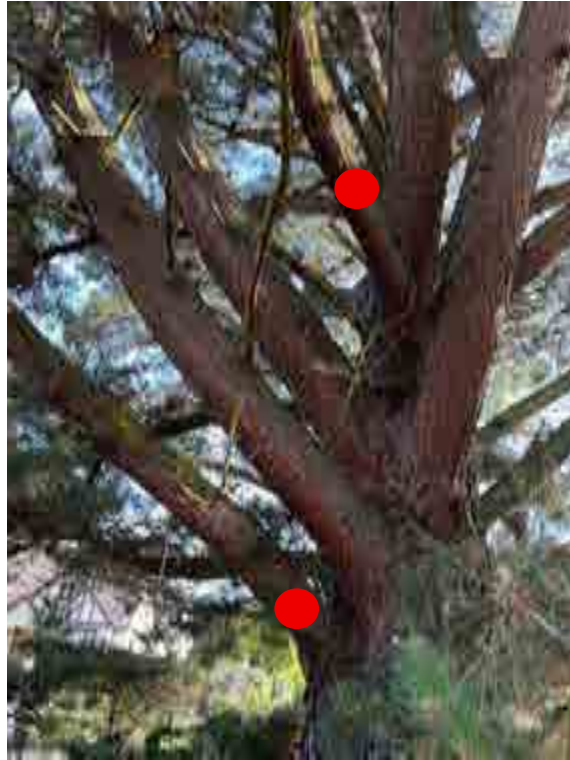
**Image 11:** 1x25cm & 1x~18cm branches in diameter likely to require removal for the building corner of unit 1 (red dots). The project arborist should be on-site to coordinate and clarify what branches need to be pruned.

Pruning the 12cm branch back to where it attaches to the trunk will result in a pruning cut that is approximately 14cm in diameter. We do not anticipate this pruning would have a significant impact on this tree. It is recommended the project arborist be on-site to coordinate the branches that will require removal.

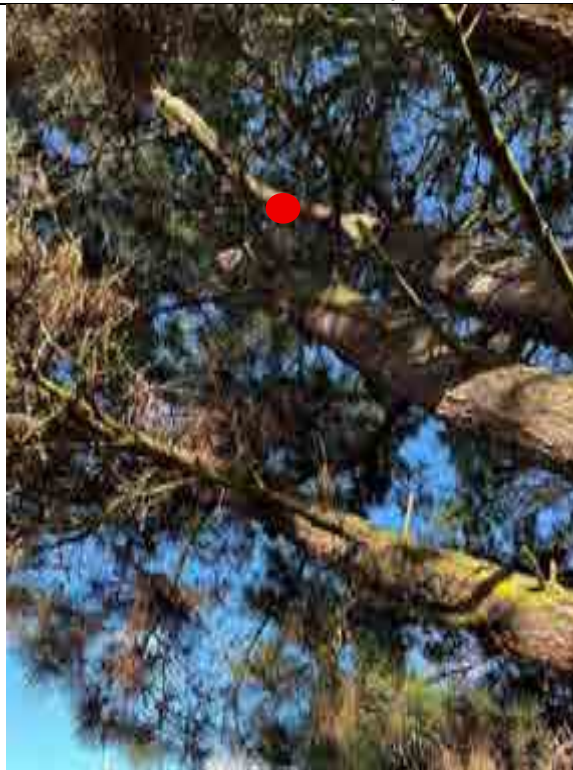
**Image 12:** 1x~18cm branch in diameter likely to require removal for the building corner of unit 1 (red dot). The project arborist should be on-site to coordinate and clarify what branches need to be pruned.

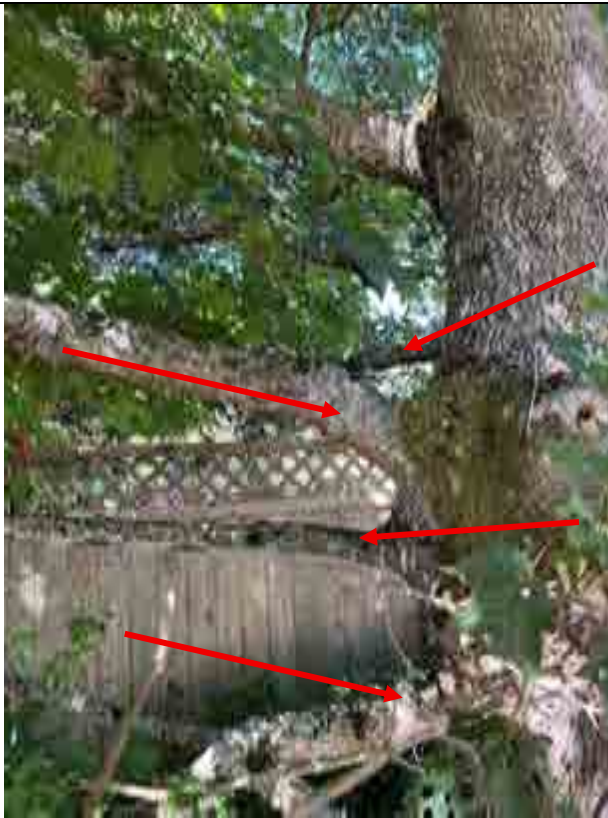
**Image 13:** 3x7cm & 1x~14cm branches in diameter from tree 2253 will likely require removal to accommodate machine access for the servicing installation and to provide clearance for the proposed sidewalk (red arrows).

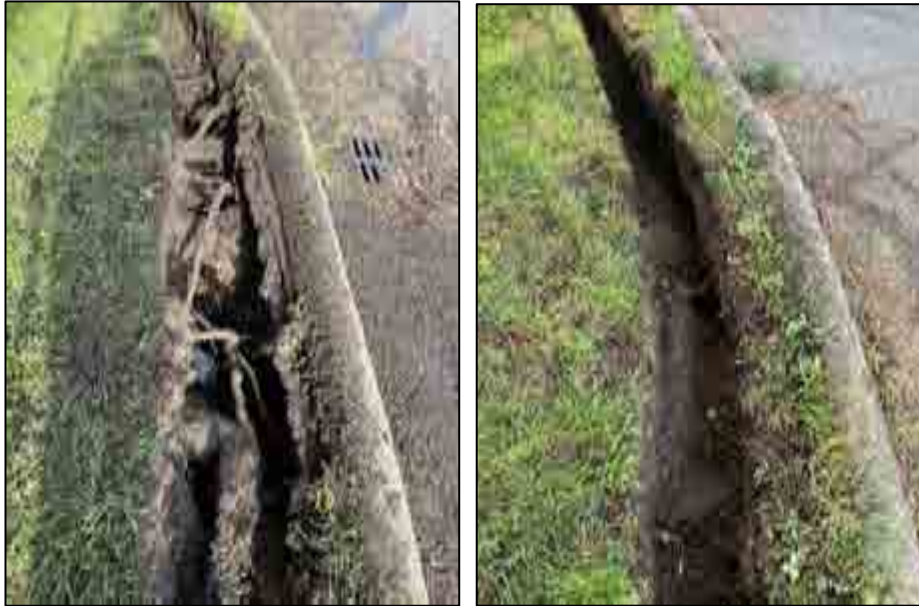
**Photographs 1 & 2:** Larger rooting structures (~10-20cm in diameter) were exposed approximately 5-6.5m east of tree 2249 near the existing catch basin on Dean Avenue (**left photo**). More larger rooting structures encountered ~5-6m northeast from the root collar of tree 2249 (**right photo**).

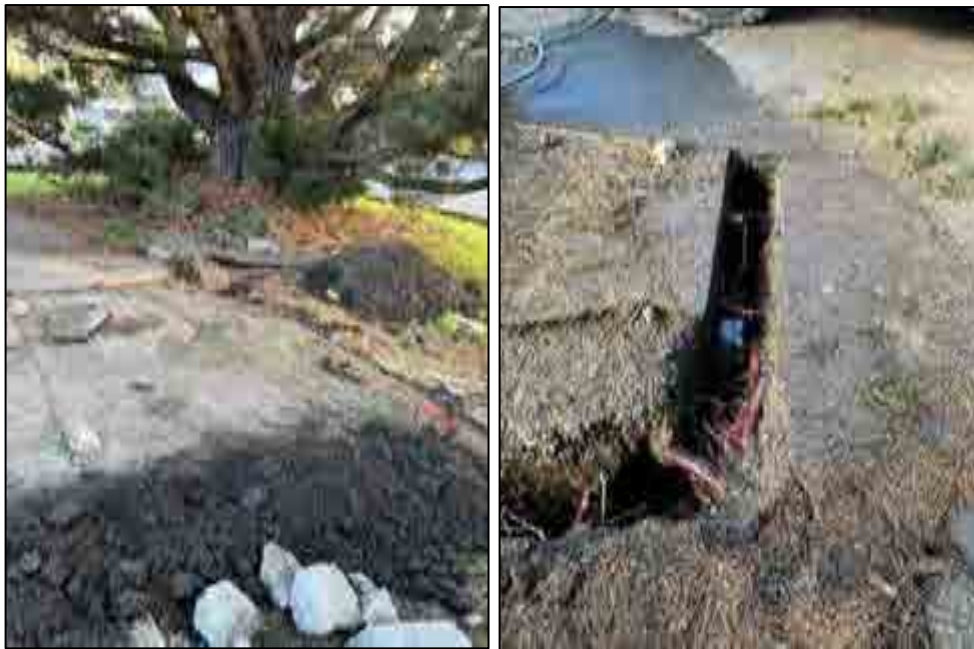
**Photographs 3 & 4:** Area on the southwest side of the tree was marked out for the exploratory excavation (**left photo**). Rooting structures encountered during the southwest hydro-vac excavation (**right photo**). These structures will have to be pruned during the over-excavation for the building footprint.

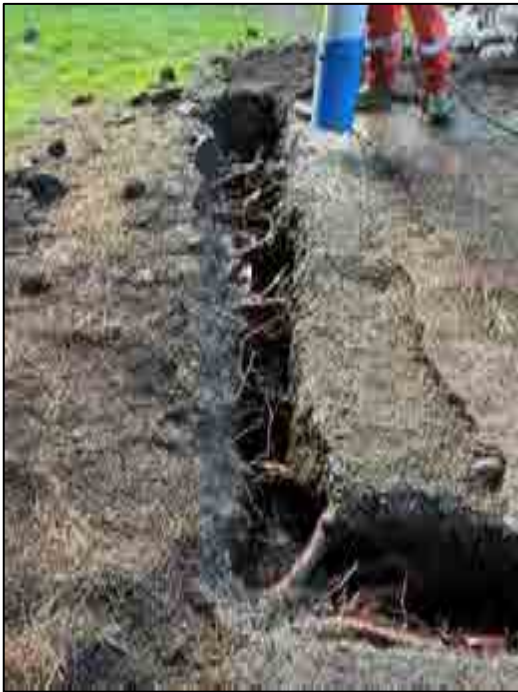
**Photographs 5 & 6:** Continuation of rooting structures encountered during southwest exploratory excavation. Some of these rooting structures will require pruning during the over-excavation for the building footprint.

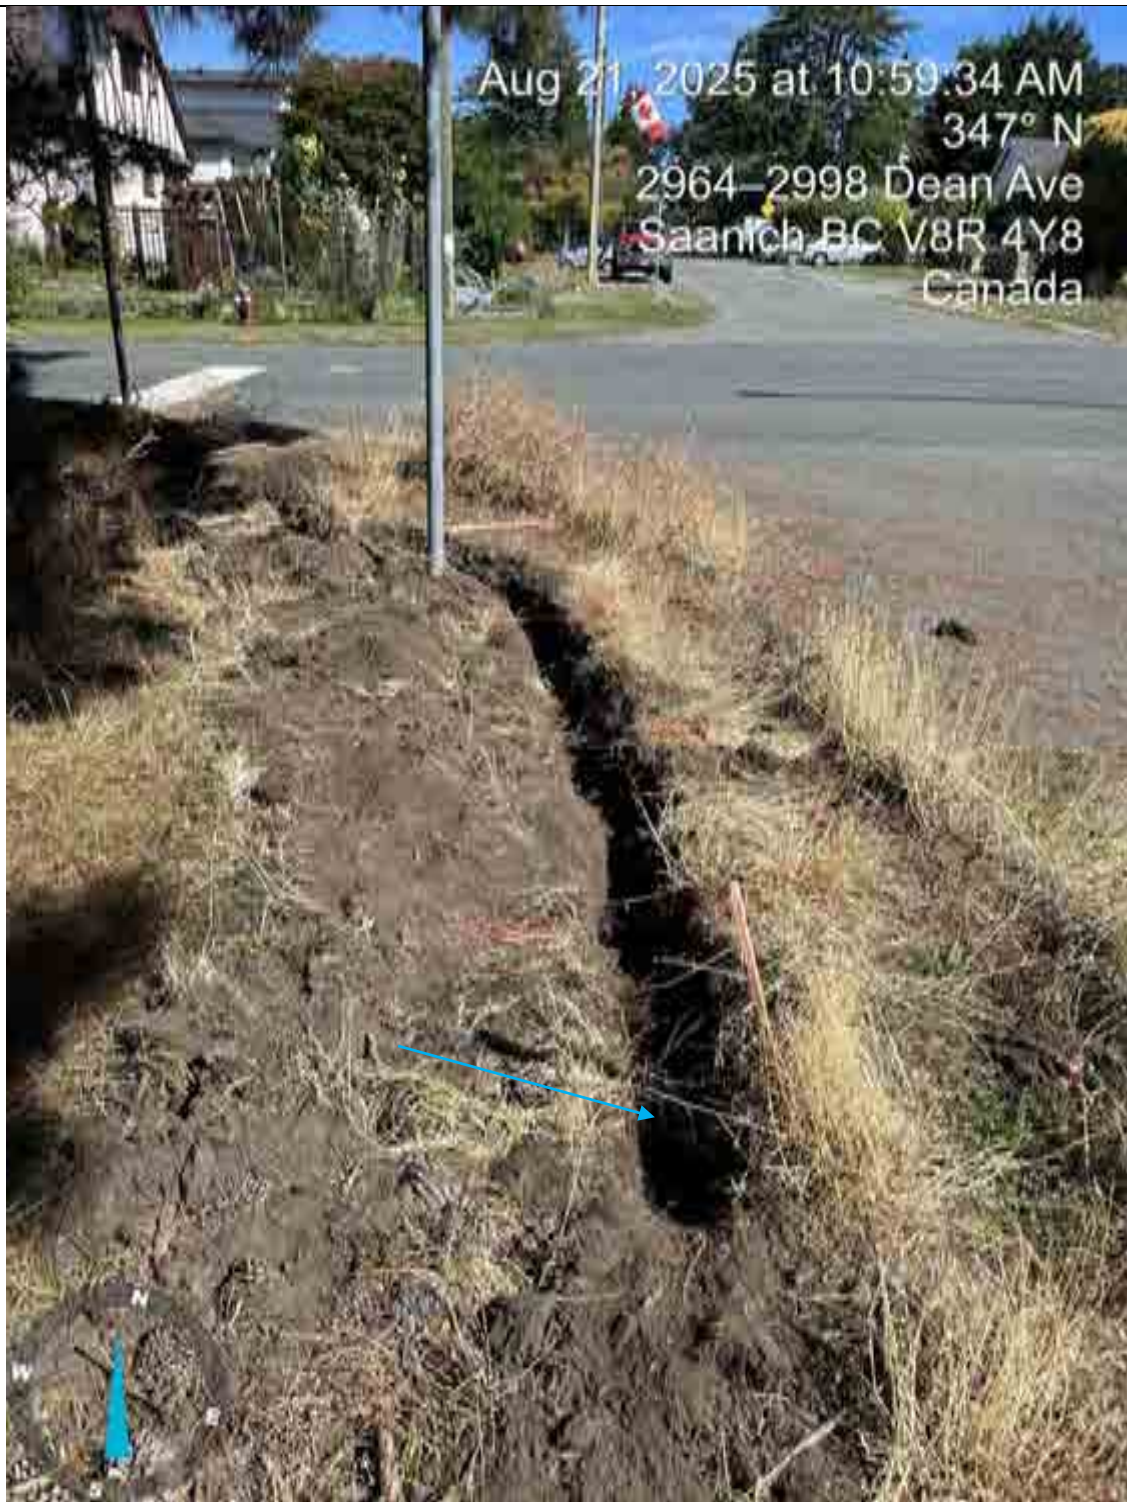
The roots encountered during all of the exploratory excavations on the east side of the tree were found to be ~20-25cm below the existing grade of the boulevard. The depth of these roots may be closer to the surface beneath the existing pavement within the existing road footprint. During our excavation we noted that the grade slopes away from the curb as it gets closer to the tree, therefore it should be possible to elevate the sidewalk above the roots and use conventional construction techniques within most of the sidewalk footprint. With the proposed top of curb being roughly 15 cm above the roadway grade, this puts it approximately 2.5-3.8cm above the existing boulevard grade. The sidewalk surface has to match the height of the concrete curb. With the roots being approximately 20-25cm below the existing boulevard grade, this gives an estimated 22.5-27.5cm of depth before the upper surface of any larger critical roots would be encountered. Typically, sidewalk installations require an excavation depth of 20cm for sub-base prep and concrete thickness. It is in our opinion that the use of alternative construction methods such as floating the sidewalk by using a geo-textile (e.g. Combigrid 30.30 – See **Appendix B**) over top of the larger rooting structures should be possible. In locations where excavation depth is required to reach material suitable for the sub-base prep and roots are encountered above this depth, these roots can be exposed by hand digging and then covered with a geotextile fabric prior to installing the base materials around the roots.

**Photograph 1:** Area of hand-dug exploratory excavation along the backside of the proposed sidewalk (wooden stake – red arrow) on the east side of tree 2249 (Dean Avenue frontage). Larger rooting structures previously encountered (blue arrow, difficult to see) were found to be 20-25cm below the existing boulevard grade.

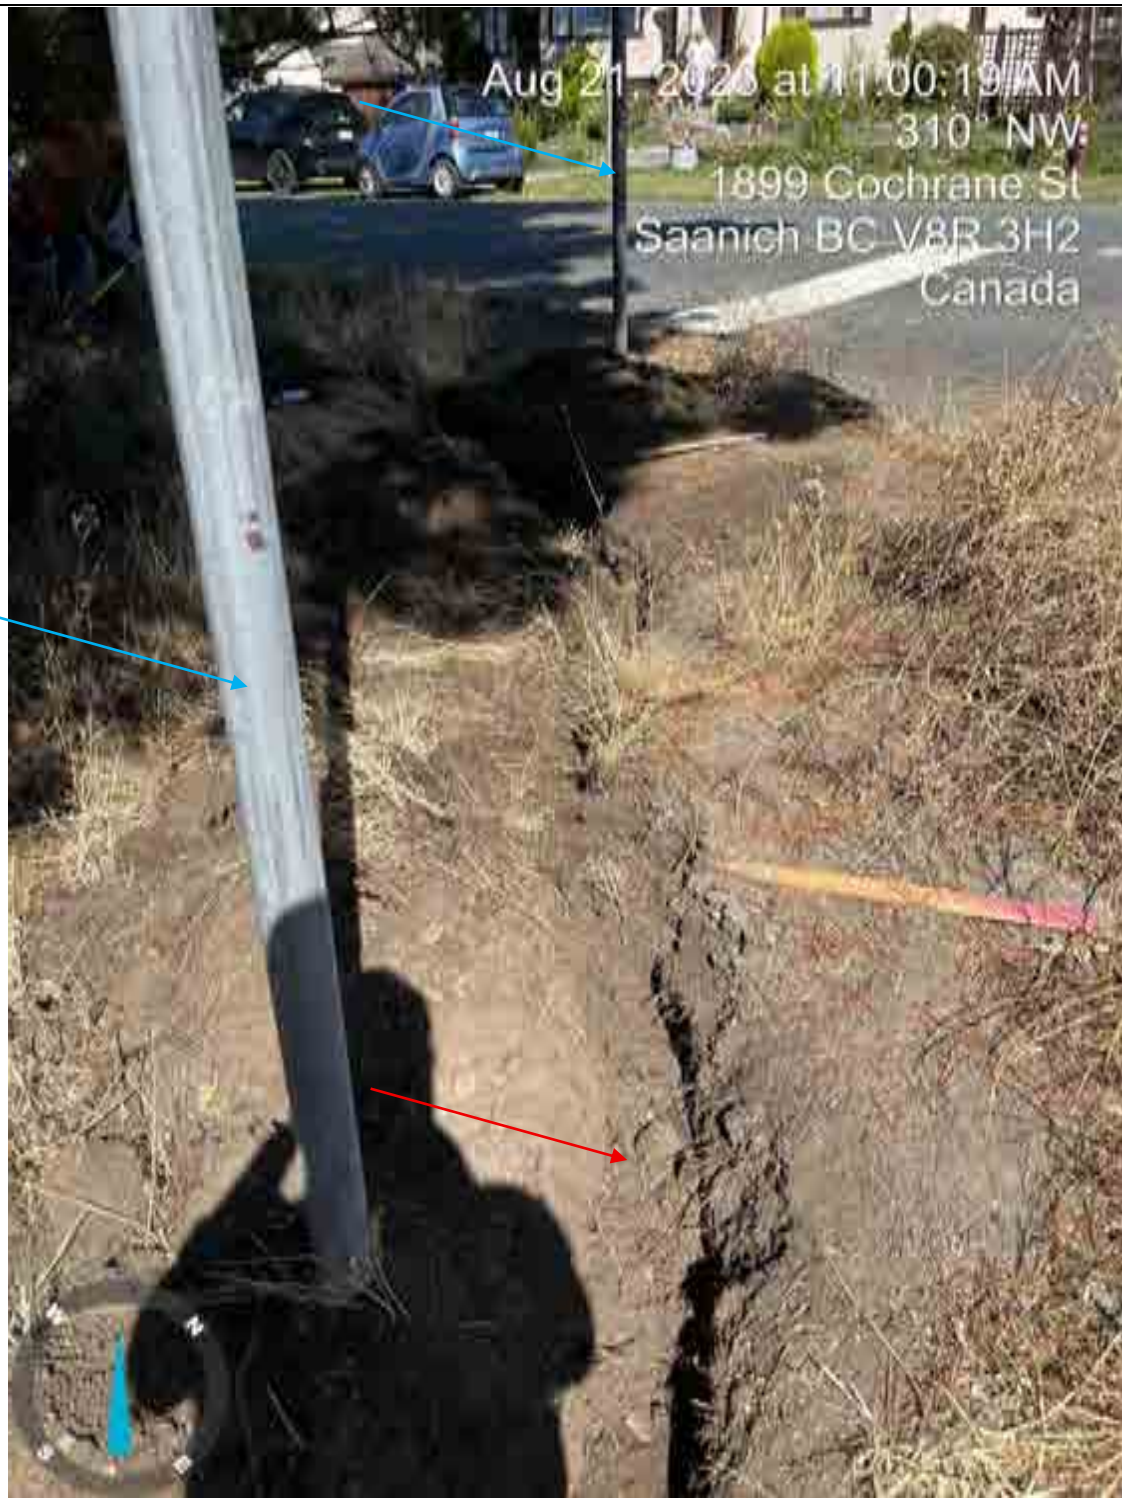
**Photograph 2:** Area of hand-dug exploratory excavation along the backside of the proposed sidewalk (wooden stake) on the northeastern side of tree 2249 (Corner of Dean Avenue and Cochrane Street). Larger ~12-14cm root (red arrow indicates approximately location, it is not visible in this photo) located near the base of existing street sign “no parking”. To our understanding the let down area of the sidewalk to the road grade is between the no parking street sign and the stop sign (blue arrows).

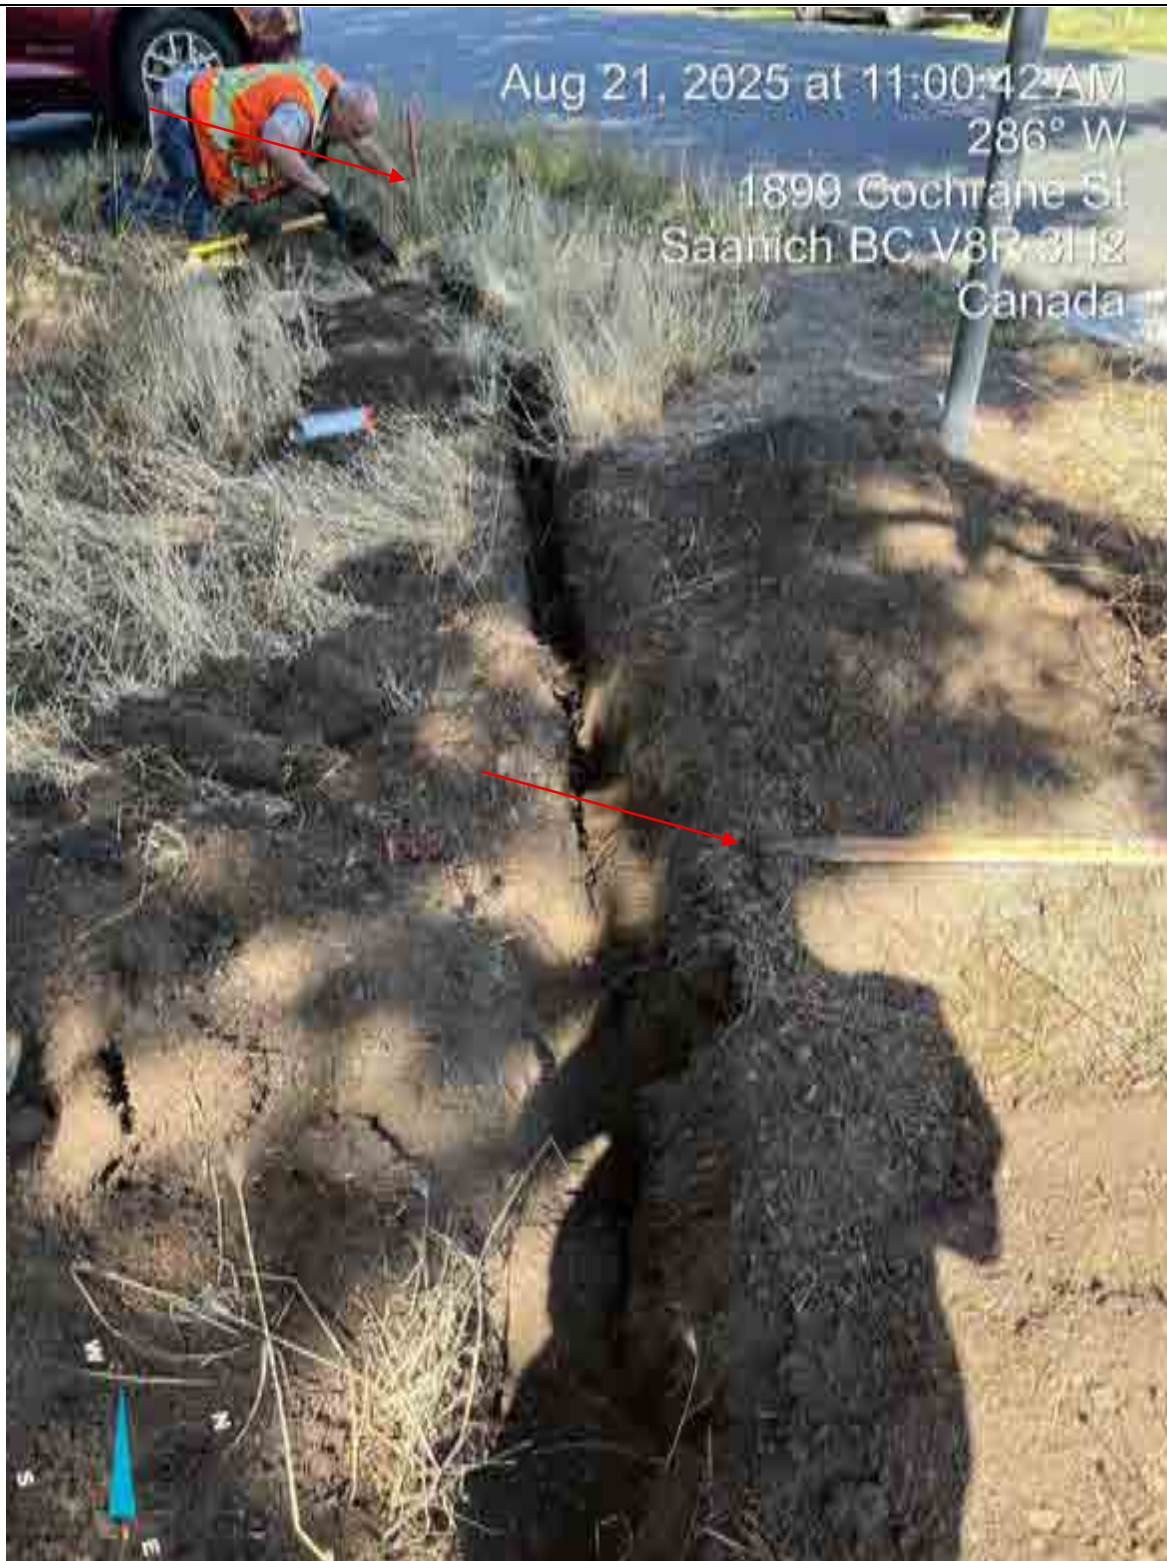
**Photograph 3:** Area of hand-dug exploratory excavation along the backside of the proposed sidewalk (wooden stake – red arrow) on the north/northeastern side of tree 2249.

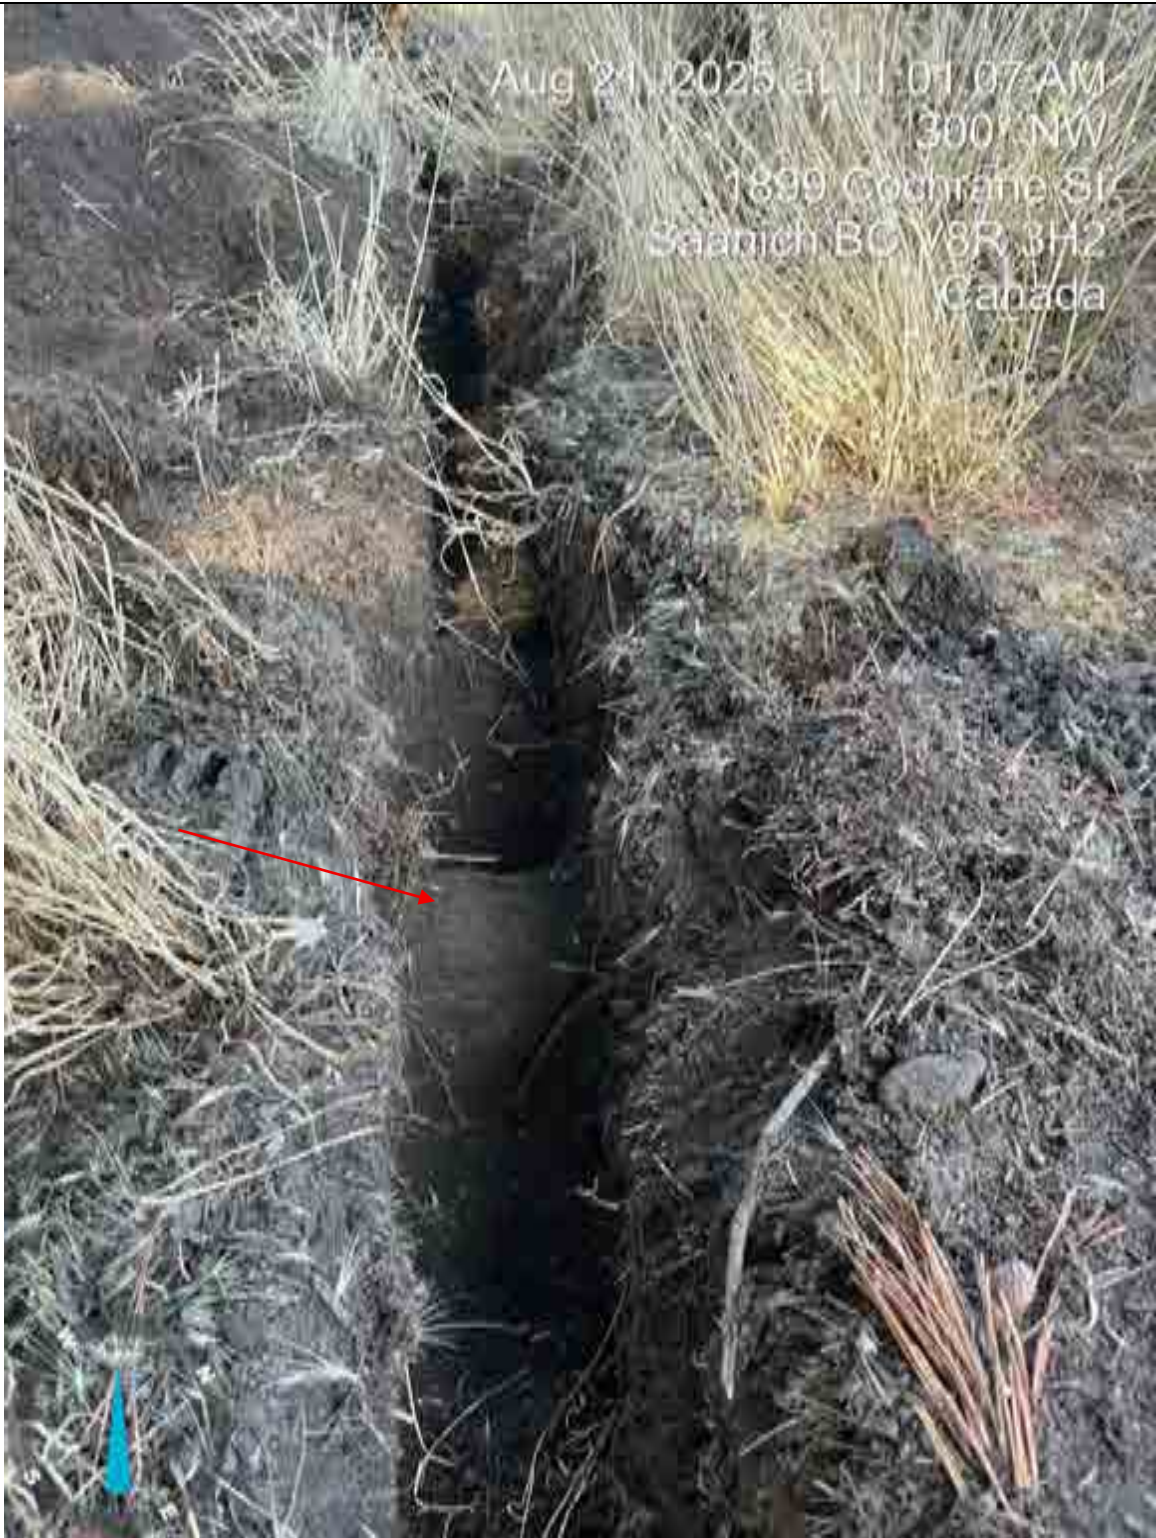
**Photograph 4:** Area of hand-dug exploratory excavation along the backside of the proposed sidewalk on the north side of tree 2249. Large ~12-14cm root (red arrow) was exposed roughly .25m west from the existing stop sign at the corner of Cochrane Street and Dean Avenue.

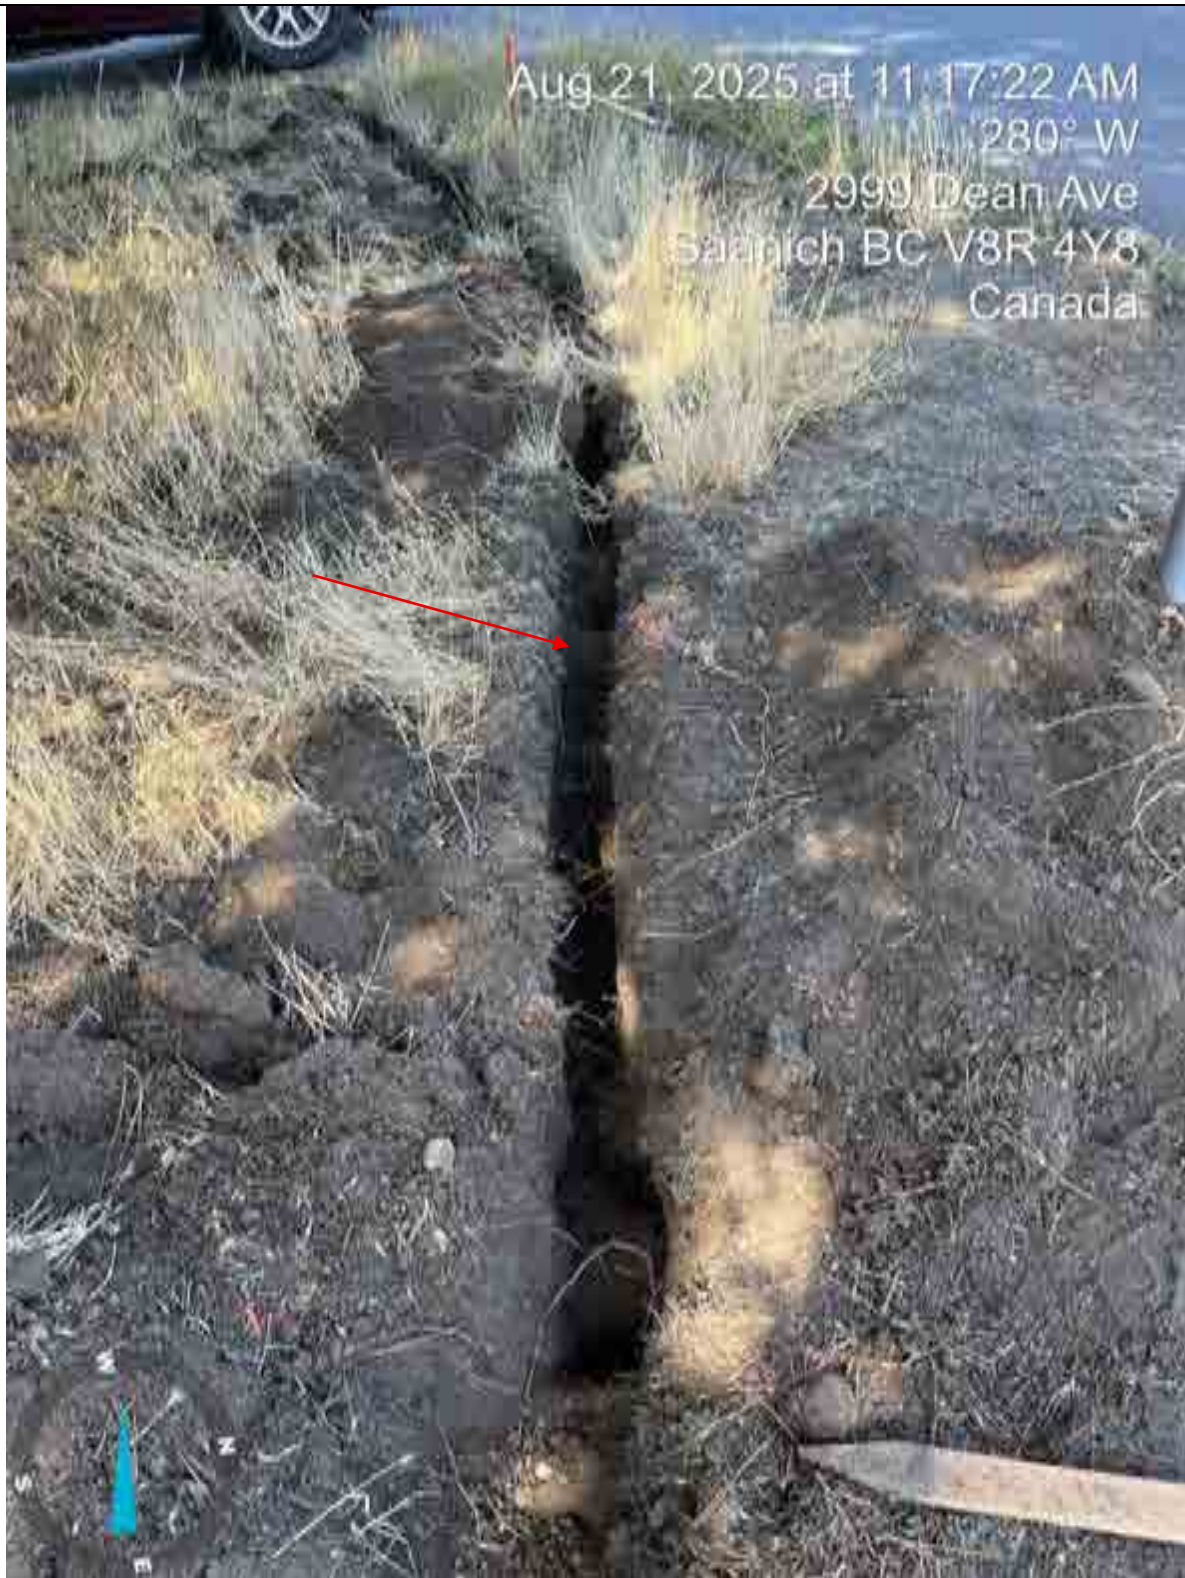
**Photograph 5:** Area of hand-dug exploratory excavation along the backside of the proposed sidewalk (wooden stake – red arrow) on the north side of tree 2249. The large ~12-14cm root exposed .25m from the existing stop sign can be seen (blue arrow).

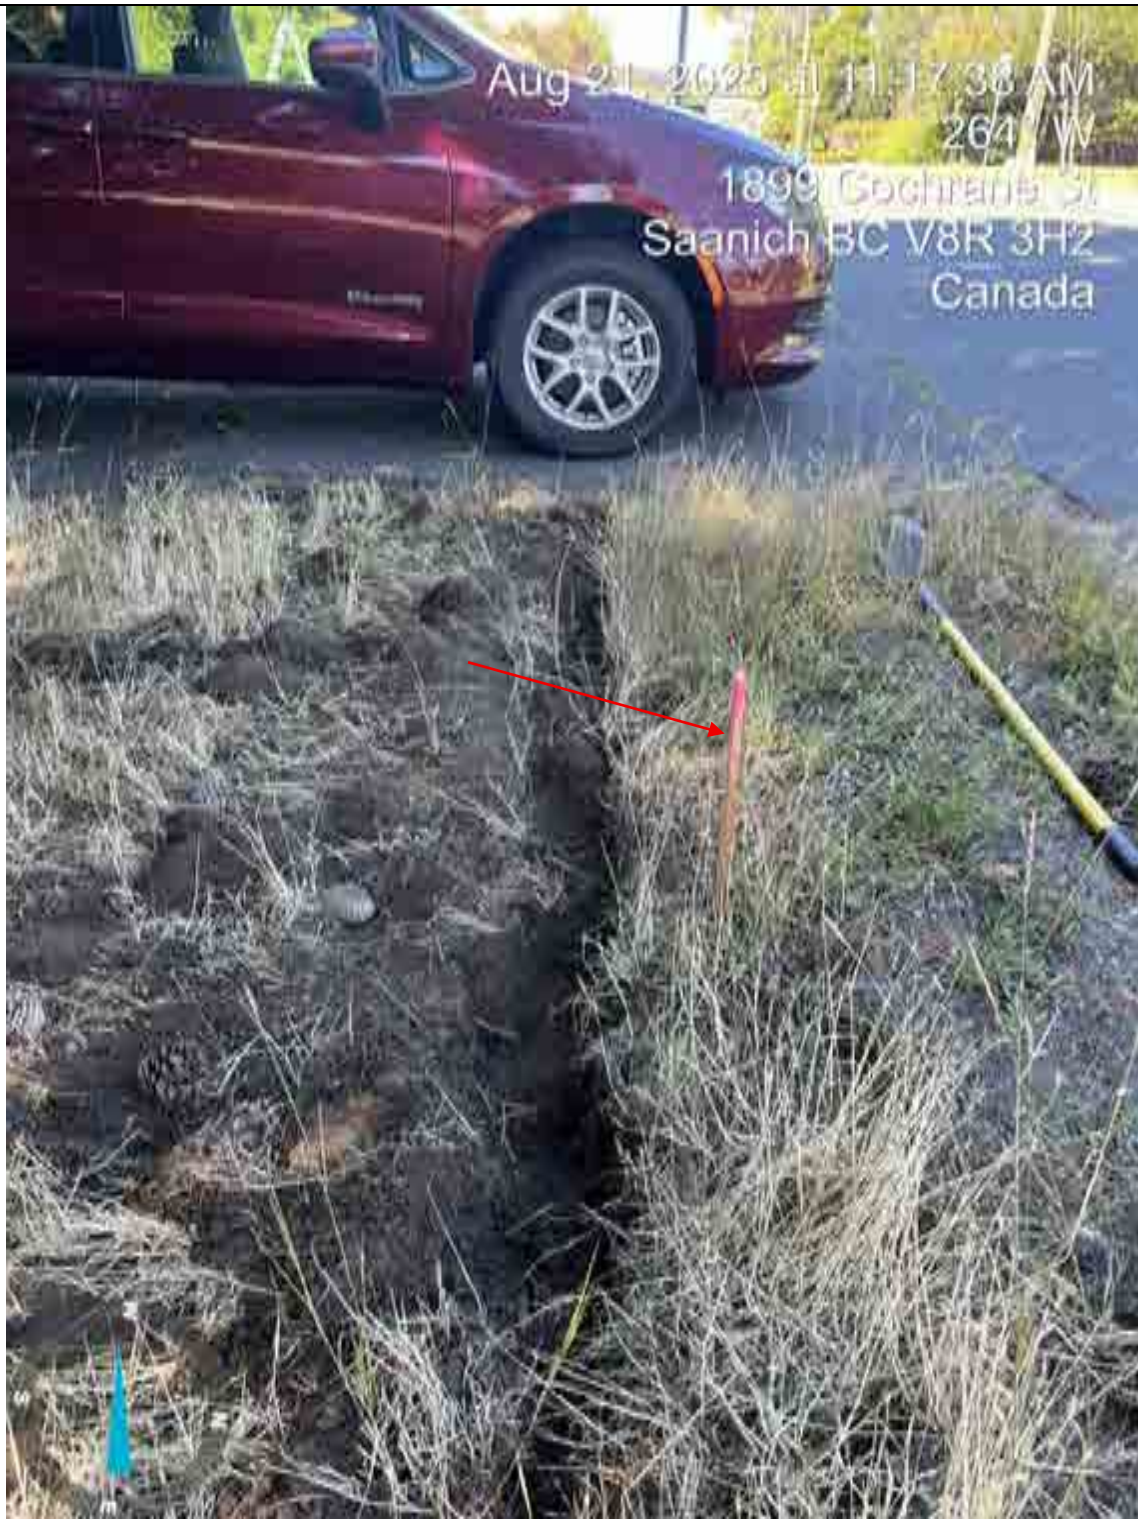
**Photograph 6:** Area of hand-dug exploratory excavation along the backside of the proposed sidewalk (wooden stake – red arrow) on the north side of tree 2249.

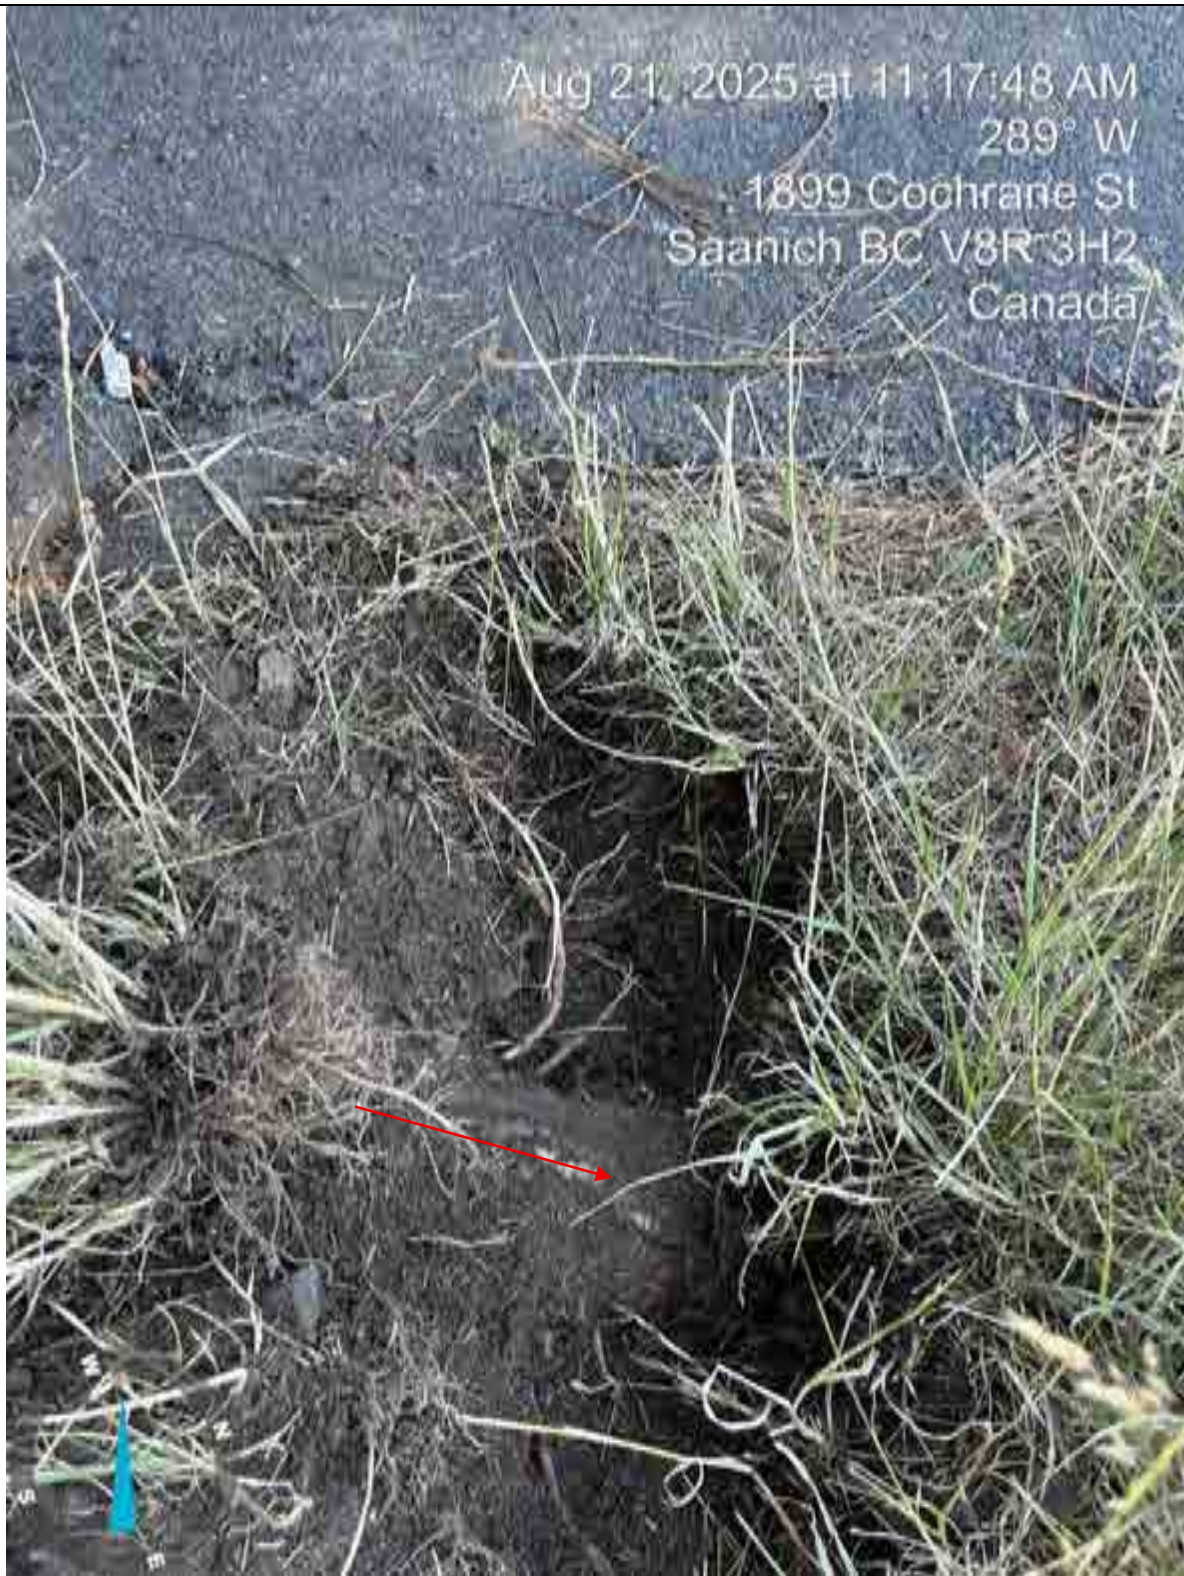
During our August 21<sup>st</sup>, 2025, exploratory excavation we found one root roughly 6cm in diameter at the edge of the existing driveway that may require pruning for the sidewalk due to its shallow depth (roughly 8cm below existing grade). We also encountered the previously exposed ~12-14cm root at the base of the existing “no parking” sign. This root was approximately 25-30cm below the existing boulevard grade. This root may be impacted by the let down area of the sidewalk. Slightly shifting the let down area of the sidewalk that connects to the roadway grade at the corner of Cochrane Street and Dean Avenue may be required to preserve this root. Based on our findings this should be feasible and involve little impacts to rooting structures.

**Photograph 7:** 1x6cm root (red arrow) exposed just east of the existing driveway during the had-dug exploratory excavation on the north side of tree 2249 along the Cochrane Street frontage.
