**1899 COCHRANE STREET**

**SAANICH, BC**

**CONSTRUCTION IMPACT ASSESSMENT**

**TREE MANAGEMENT PLAN**

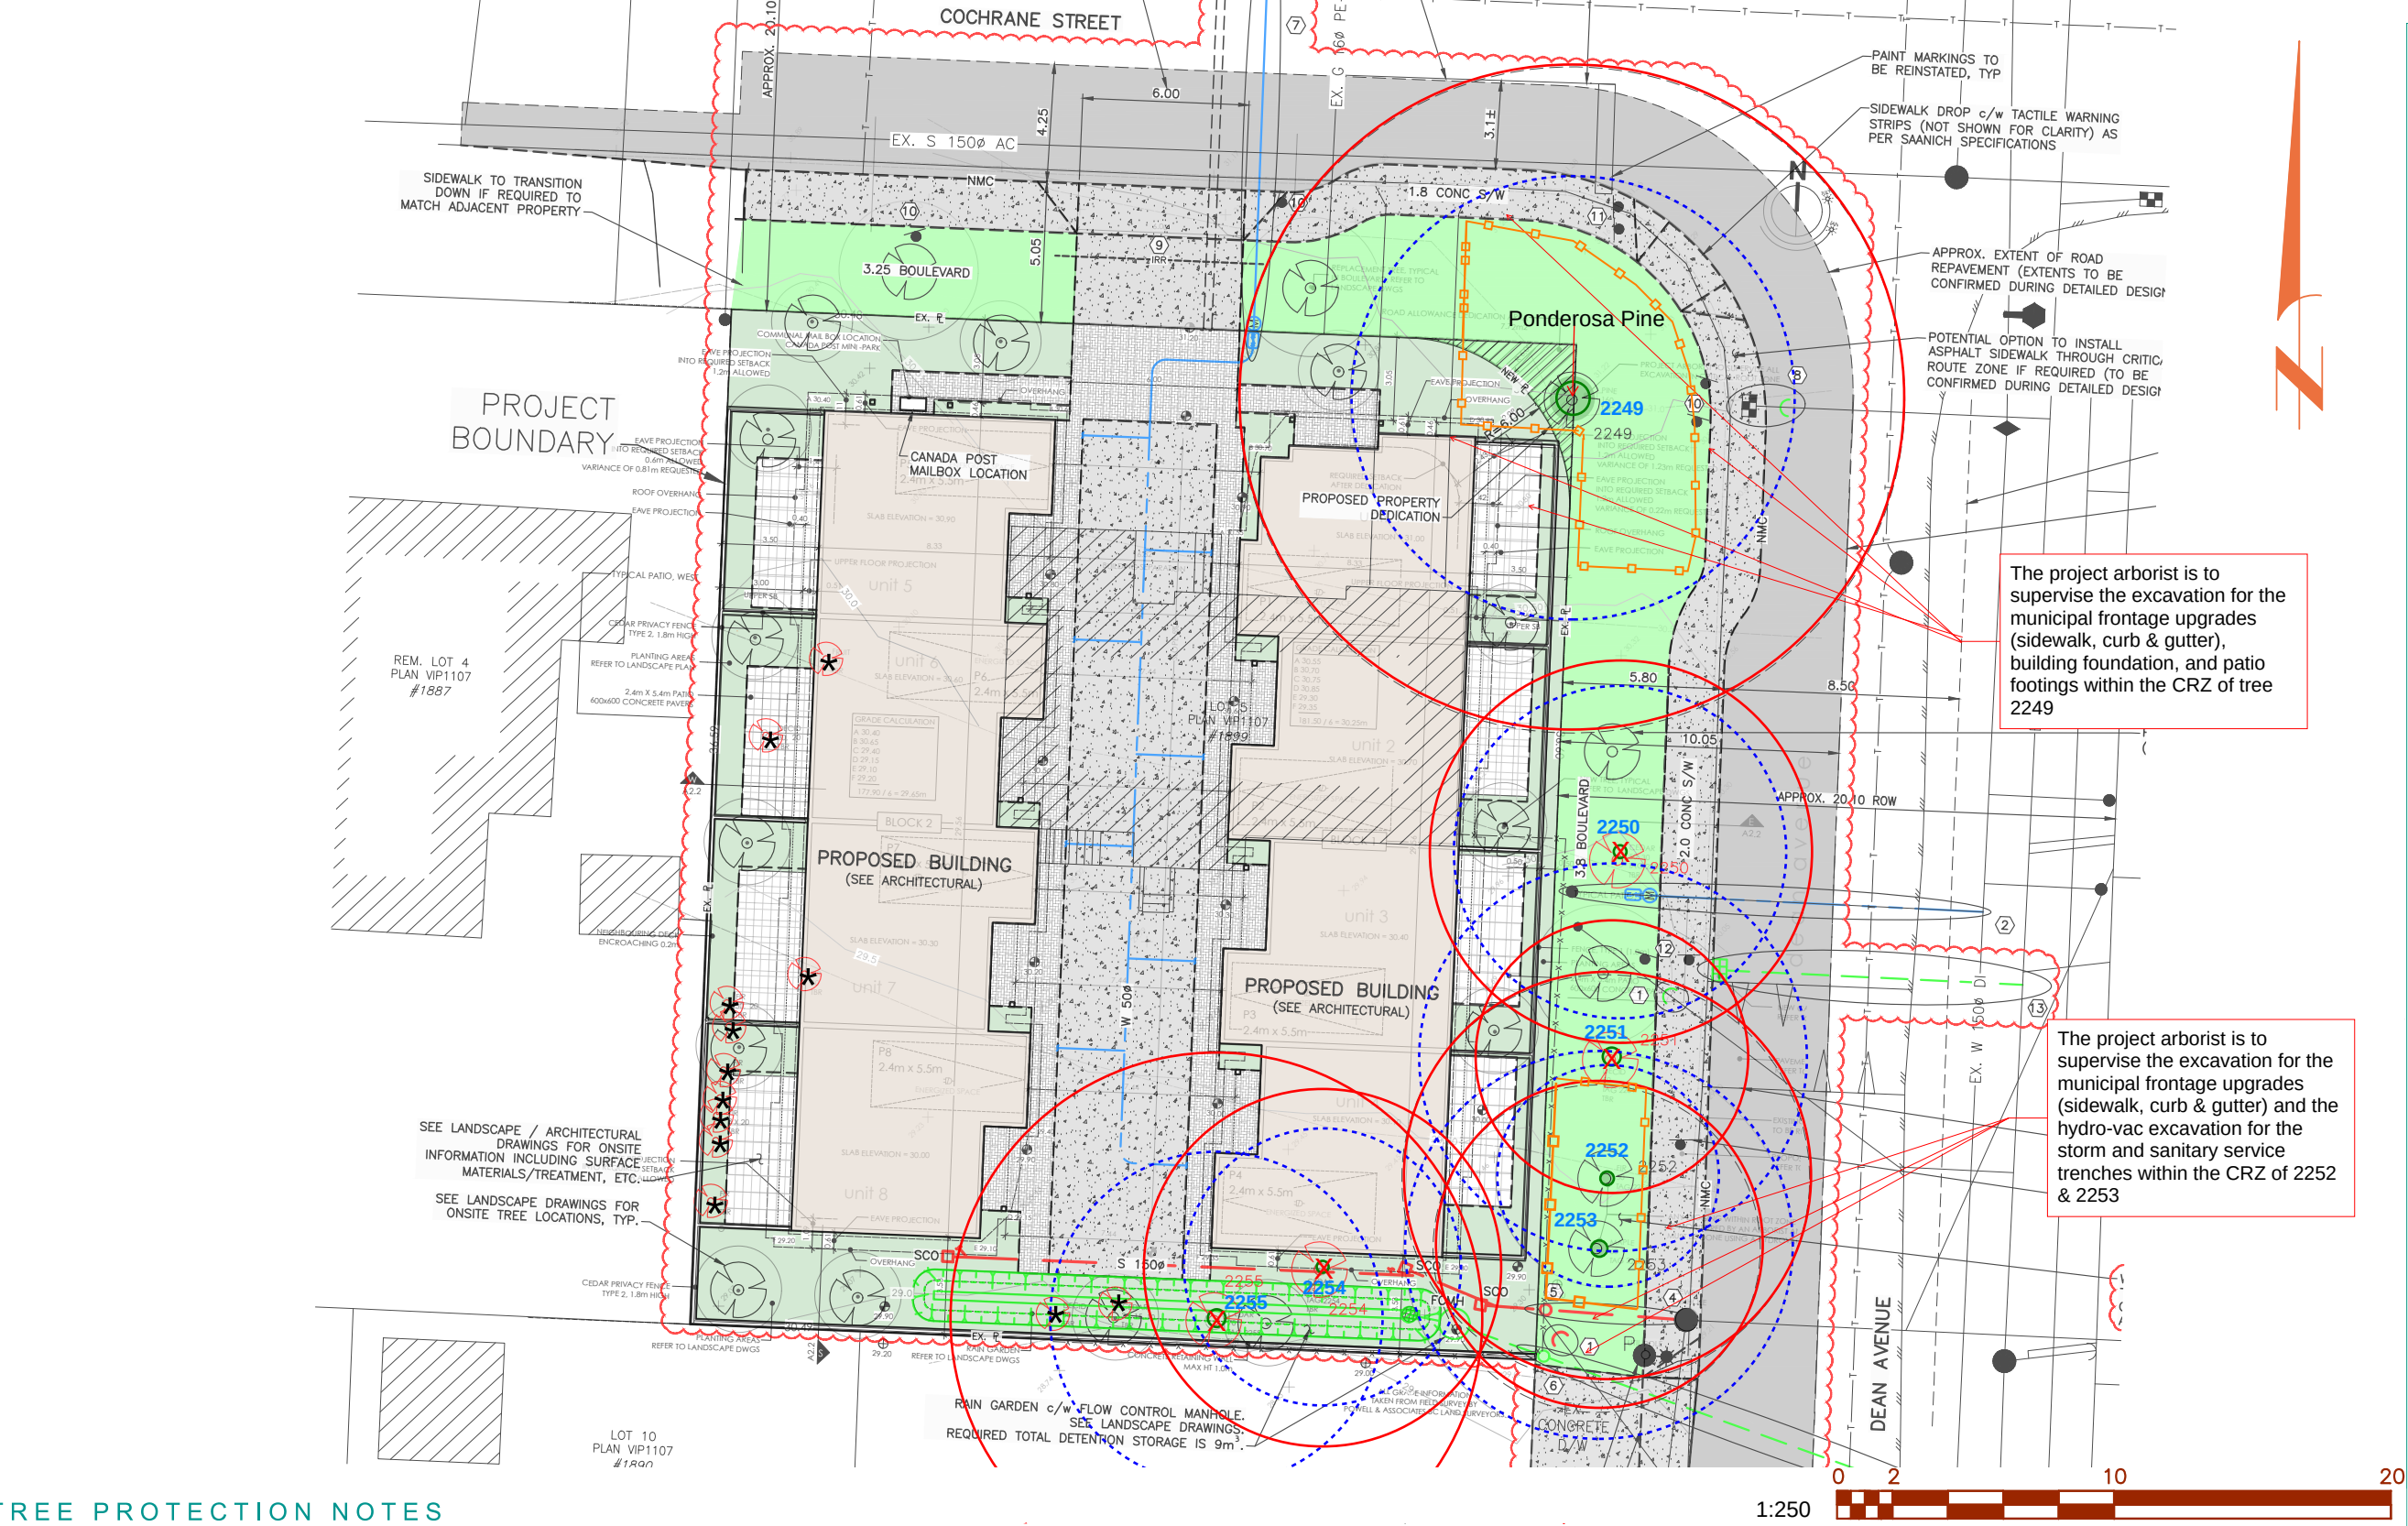
The project arborist is to supervise the excavation for the municipal frontage upgrades (sidewalk, curb & gutter), building foundation, and patio footings within the CRZ of tree 2249

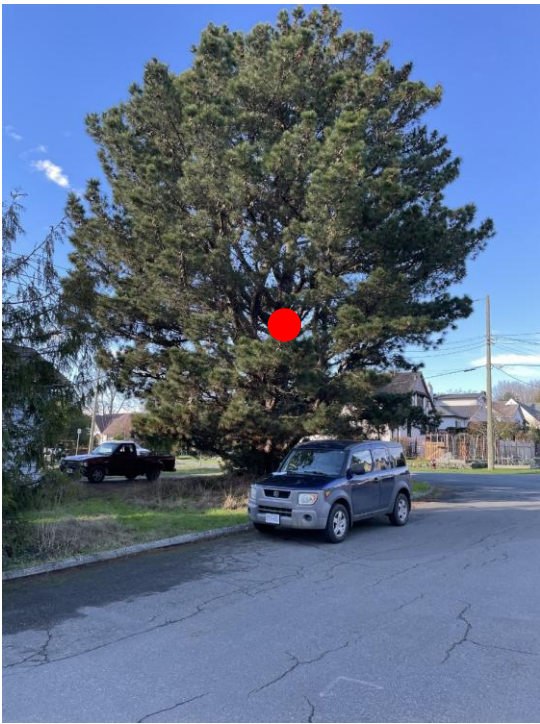
**Tree ID: 2249** – Is a large Ponderosa pine tree located at the corner of the Cochrane Street and Dean Avenue. This tree is likely to be impacted by the foundation, patio area and building clearance required for unit 1, along with the municipal frontage upgrades (sidewalk, curb and gutter) at the corner of Cochrane Street and Dean Avenue.

Tree 2249 (red dot). Proposed as Retain\*

An existing asphalt driveway currently resides less than 2m west from tree 2249. It is recommended that this driveway remain in place for the duration of the demolition phase and for as long as possible during the construction phase of this project.

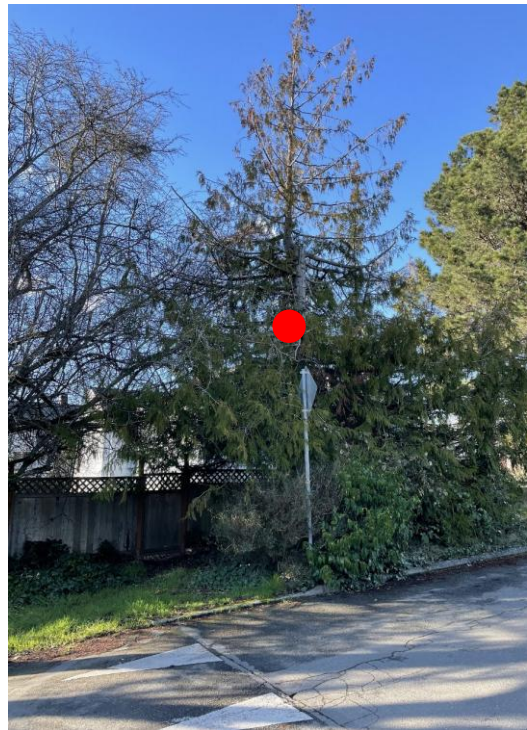
| Tag # | Surveyed ?<br>(Yes/No) | Location<br>(On, Off, Shared, City) | Bylaw protected ?<br>(Yes/No) | Name | | DBH (cm) | crown radius (m) | Critical root zone radius (m) | Condition | | Relative tolerance | General field observations/remarks | Tree retention/location comments | Retention status |
|---|---|---|---|---|---|---|---|---|---|---|---|---|---|---|
| 2250 | Yes | City | Yes | Western Red cedar | Thuja plicata | 46.00 | 6 | 6.9 | Fair | Poor | Poor | Dieback and decline in canopy. Leaders topped for hydro clearance | See section 8.1.1 | Remove |

**Tree ID's: 2250, 2251** – Are located on the municipal boulevard along Dean Avenue. These trees are located where they are likely to be impacted by the proposed construction. These trees are selected for removal based on a combination of impacts and pre-existing condition.

Tree 2250 (red dot). Selected for removal.

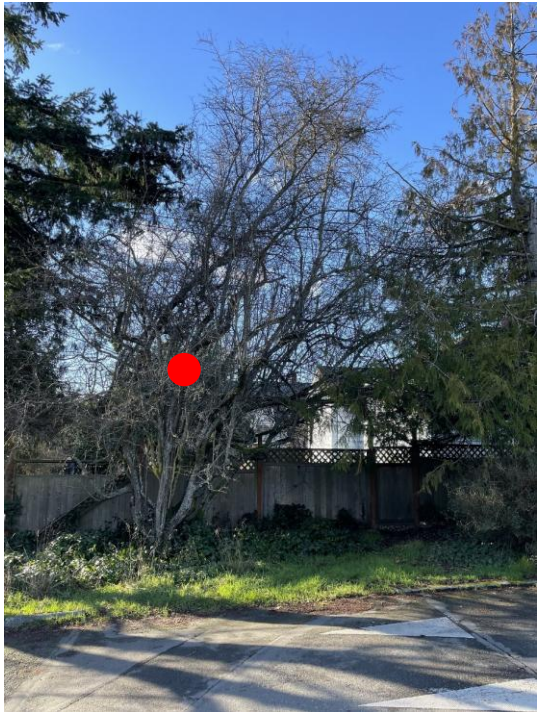
| Tag # | Surveyed ?<br>(Yes/No) | Location<br>(On, Off, Shared, City) | Bylaw protected ?<br>(Yes/No) | Name | | DBH (cm) | crown radius (m) | Critical root zone radius (m) | Condition | | Relative tolerance | General field observations/remarks | Tree retention/location comments | Retention status |
|---|---|---|---|---|---|---|---|---|---|---|---|---|---|---|
| 2251 | Yes | City | Yes | English hawthorn | Crataegus monogyna | 2x20,3x15,3x10 | 7 | 4.92 | Good | Fair | Moderate | Canopy asymmetry. Side of canopy pruned for hydro line clearance | See section 8.1.1 | Remove |

Tree 2251 (red dot). Selected for removal.

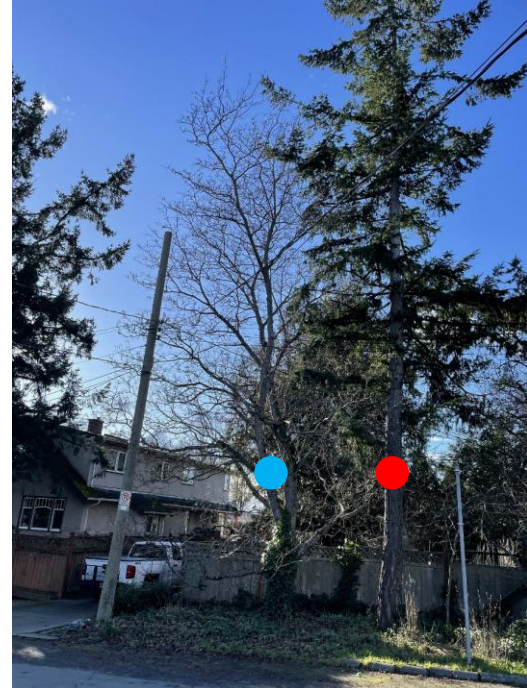
| Tag # | Surveyed ?<br>(Yes/No) | Location<br>(On, Off, Shared, City) | Bylaw protected ?<br>(Yes/No) | Name | | DBH (cm) | crown radius (m) | Critical root zone radius (m) | Condition | | Relative tolerance | General field observations/remarks | Tree retention/location comments | Retention status |
|---|---|---|---|---|---|---|---|---|---|---|---|---|---|---|
| 2252 | Yes | City | Yes | Douglas-fir | Pseudotsuga menziesii | 49.00 | 4 | 7.35 | Good | Fair | Poor | Side pruned for hydro clearance | See section 8.1.1 | Retain* |
| 2253 | Yes | City | Yes | Norway maple | Acer platanoides | 59.00 | 7 | 5.9 | Good | Fair | Good | Side pruned for hydro clearance | See section 8.1.1 | Retain* |

Trees 2252 (red dot) & 2253 (blue dot). Both proposed as Retain\*

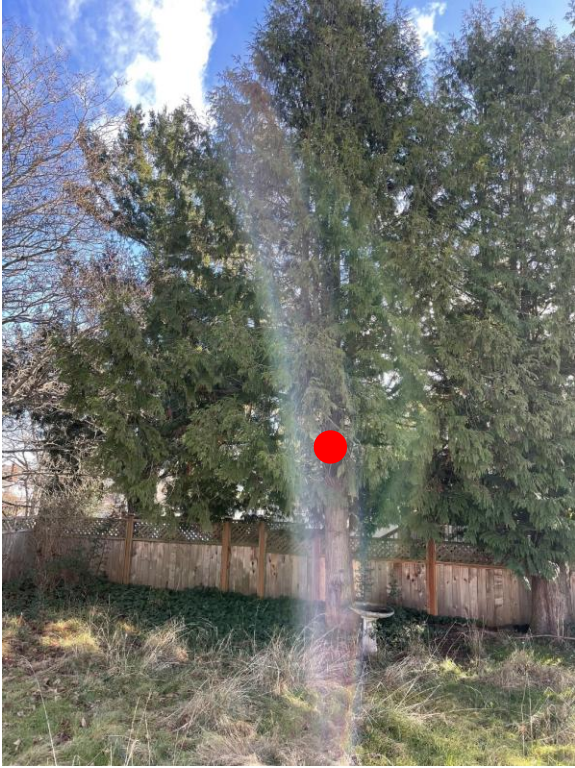
| Tag # | Surveyed ?<br>(Yes/No) | Location<br>(On, Off, Shared, City) | Bylaw protected ?<br>(Yes/No) | Name | | DBH (cm) | crown radius (m) | Critical root zone radius (m) | Condition | | Relative tolerance | General field observations/remarks | Tree retention/location comments | Retention status |
|---|---|---|---|---|---|---|---|---|---|---|---|---|---|---|
| 2254 | Yes | On | Yes | Western Red cedar | Thuja plicata | 43.00 | 5 | 6.45 | Good | Fair | Poor | Topped historically | See section 8.2.1 | Remove |

Tree 2254 (red dot). Proposed for removal.

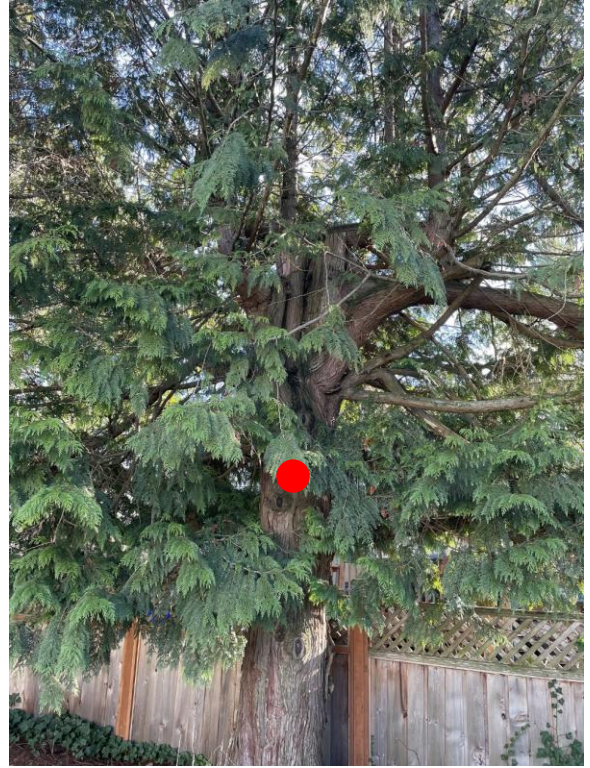
| Tag # | Surveyed ?<br>(Yes/No) | Location<br>(On, Off, Shared, City) | Bylaw protected ?<br>(Yes/No) | Name | | DBH (cm) | crown radius (m) | Critical root zone radius (m) | Condition | | Relative tolerance | General field observations/remarks | Tree retention/location comments | Retention status |
|---|---|---|---|---|---|---|---|---|---|---|---|---|---|---|
| 2255 | Yes | On | Yes | Western Red cedar | Thuja plicata | 64.00 | 6 | 9.6 | Good | Poor | Poor | Topped historically. Weakness and decay at union | See section 8.2.1 | Remove |

Tree 2255 (red dot). Proposed for removal.

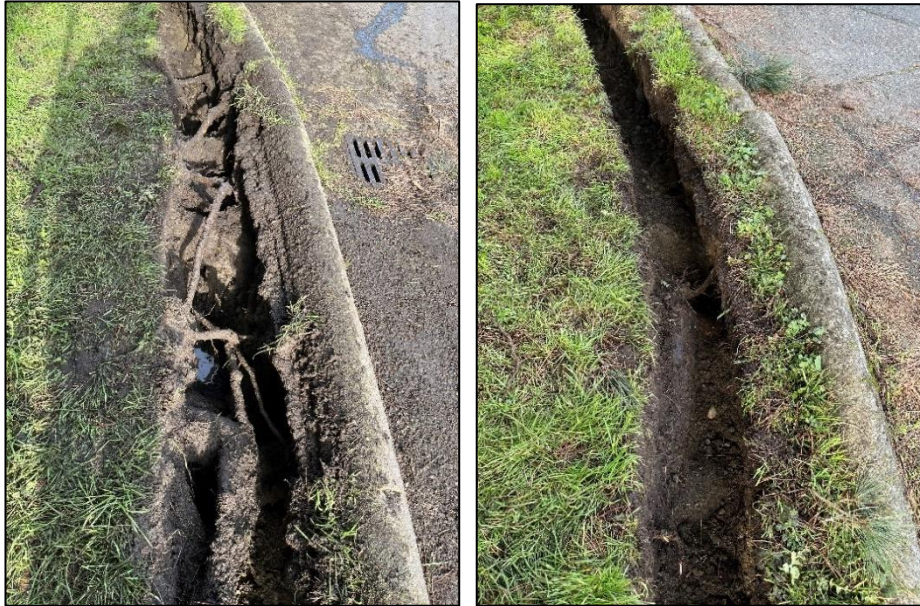
**Sidewalk and curb** – Along the proposed sidewalk edge, numerous rooting structures (ranging from ~3-20cm in diameter) were observed to be extending from tree 2249 approximately 6.5 metres east from the base of the tree. Larger rooting structures (1x~16-20cm, 1x~14cm & 3x~8-10cm in diameter) were mainly concentrated in the location of the existing catch basin. In discussions with the municipal parks department, it was decided that if the street grade at this corner of the intersection could be elevated it would permit the sidewalk and possibly the curb to be installed above the root structures in this location. The parks representatives expressed an opinion that if the catch basin could be located further to the south along Dean Avenue that they would be comfortable in pruning any roots encountered at the curb edge if the street grade could not be elevated sufficiently above all of the deeper root structures. Alternatively using an asphalt curb installed on top of the asphalt street surface in this location instead of a concrete curb is likely to eliminate the requirement for pruning any roots. The project arborist is to supervise the excavation required for the sidewalk & curb and gutter locations within the CRZ of this tree. See **Appendix A, T1**.

**Photographs 1 & 2:** Larger rooting structures (~10-20cm in diameter) were exposed approximately 6.5 east of tree 2249 near the existing catch basin on Dean Avenue (**left photo**). More larger rooting structures encountered ~6m northeast from the root collar of tree 2249 (**right photo**).

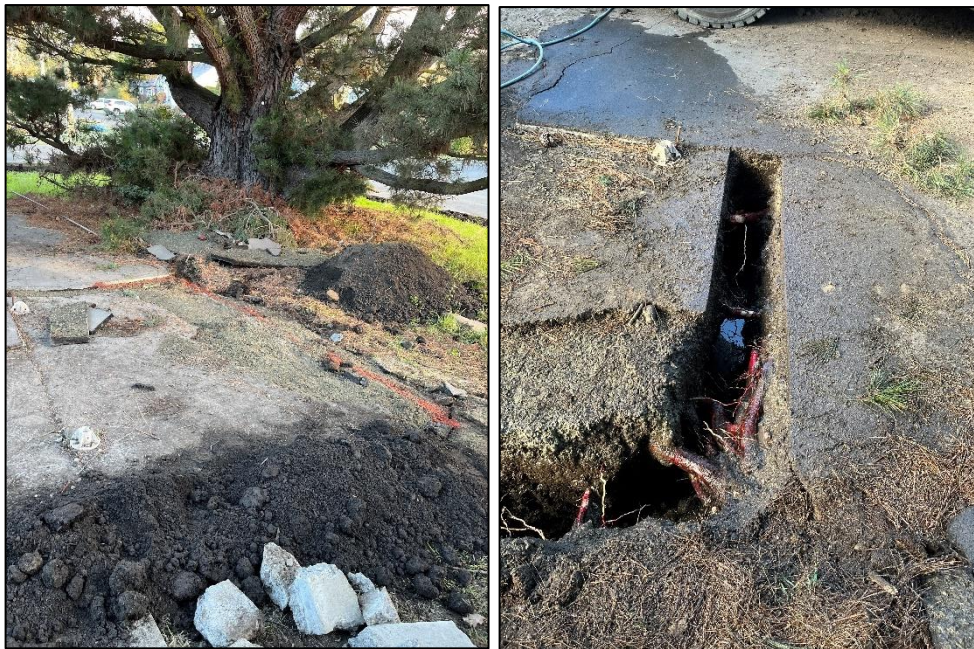
**Building footprint** – Smaller rooting structures were encountered during the southeastern exploratory excavation for the proposed building foundation of unit 1 then the ones there were exposed during the curb and gutter excavation. Roots encountered ranged from the size of 2-8cm in diameter. In our opinion pruning the roots in this location is unlikely to have a detrimental impact on the future health and survival of this tree long term. The option of relocating the building foundation 1-2m further west from this tree was discussed, however we believe this is unlikely to change the impacts significantly. Pruning of the tree canopy in this location will be required for adequate clearance from the roof and gutters. It is anticipated that the pruning will require the removal of 1x 25cm scaffold limb, 1x 40cm scaffold limb and 2x ~18-20cm scaffold limbs in order to provide building clearance for unit 1. Pruning to remove the above-mentioned limbs and any additional pruning for sidewalk & the proposed patio clearance is likely to be less than 20% of the live canopy growth. Although it may not be feasible, relocating the building corner 1-2 metres to the south may reduce the requirement to remove the larger 40cm scaffold limb along that would require pruning in the current location. The project arborist is to supervise the excavation for the proposed building foundation of unit 1 within the CRZ of this tree and all pruning is to be done by an ISA certified Arborist and done to the industries best current management practices. See **Appendix A, T1**.

**Photographs 3 & 4:** Area on the southwest side of the tree was marked out for the exploratory excavation (**left photo**). Rooting structures encountered during the southwest hydro-vac excavation (**right photo**).

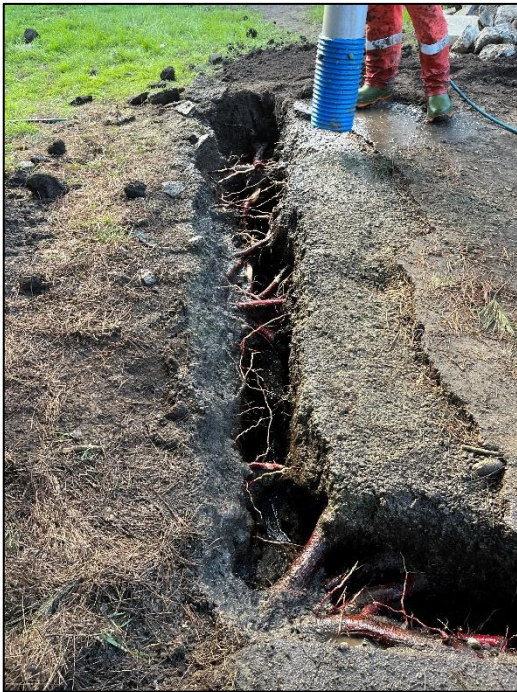
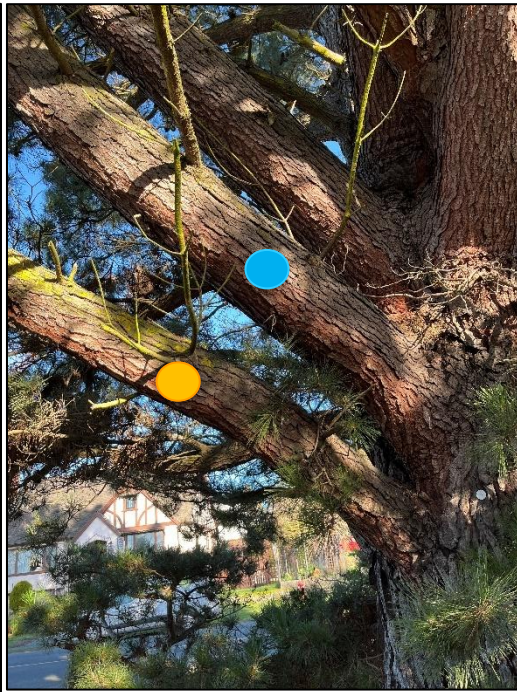
**Photographs 5 & 6:** Continuation of rooting structures encountered during southwest exploratory excavation (**left photo**). Anticipated large scaffold limbs (25cm in diameter, orange dot, and 40cm in diameter, blue dot) that will likely require removal to accommodate proposed building unit #1 (**right photo**).

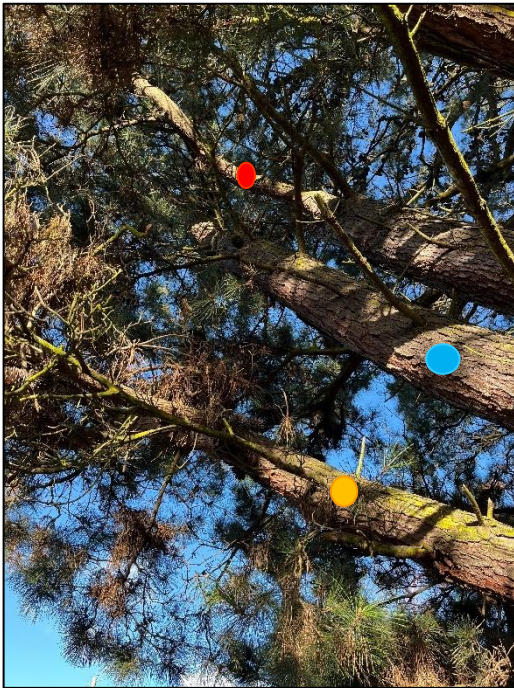
**Photograph 7:** 25cm scaffold limb (orange dot), 40cm scaffold limb (blue dot), and ~18-20cm limb (red dot), are likely to require removal to accommodate proposed building unit #1.
