**Re: Geotechnical Conditions Summary: Proposed Mixed-Use Development  
773 Cordova Bay Road, Saanich, B.C.**

## 1.0 INTRODUCTION

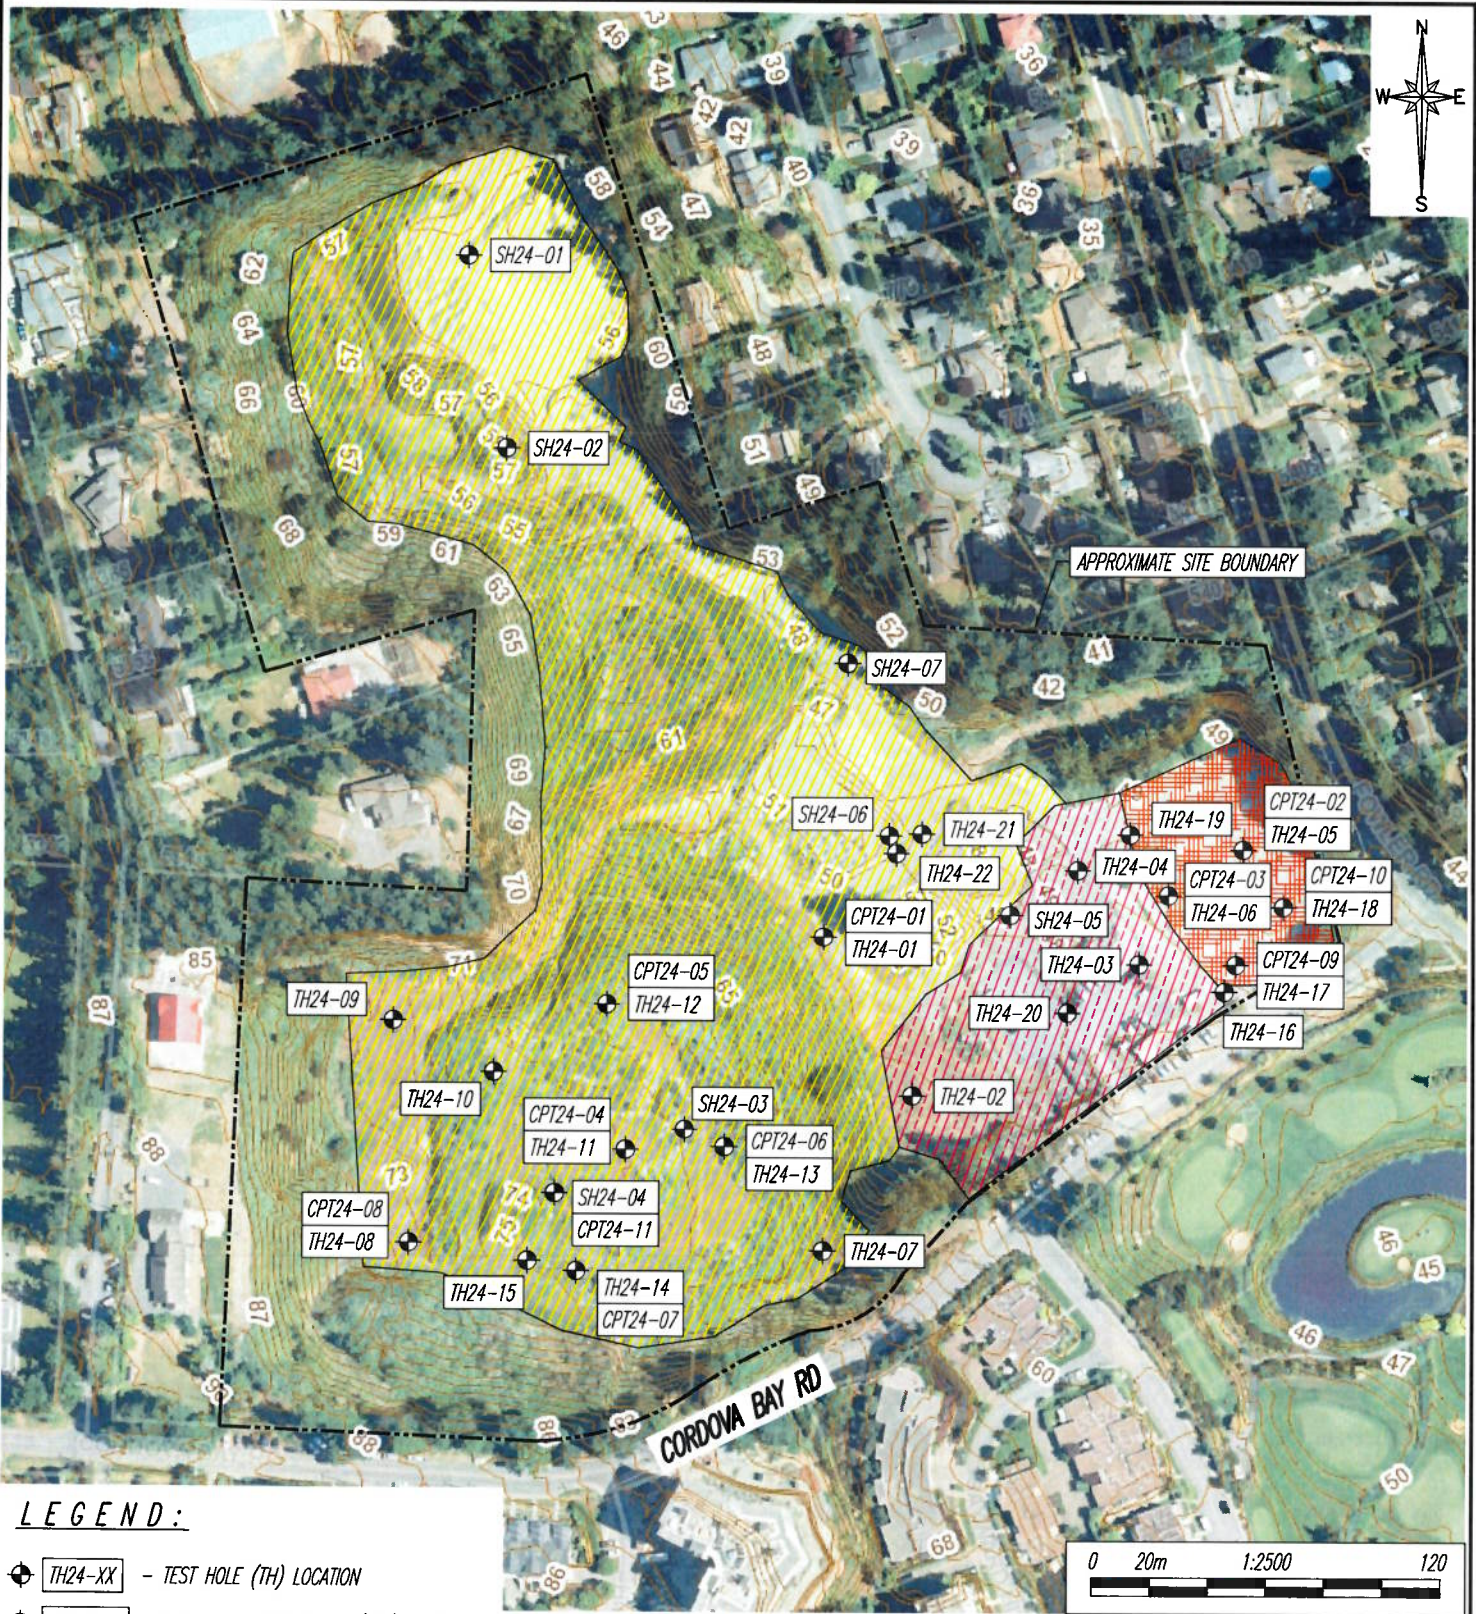
**PROPOSED DEVELOPMENT**  
773 CORDOVA BAY ROAD, VICTORIA, B.C.  
**SITE PLAN**

- ⊕ TH24-XX - TEST HOLE (TH) LOCATION
- ⊕ CPT24-XX - CONE PENETRATION TEST (CPT) LOCATION

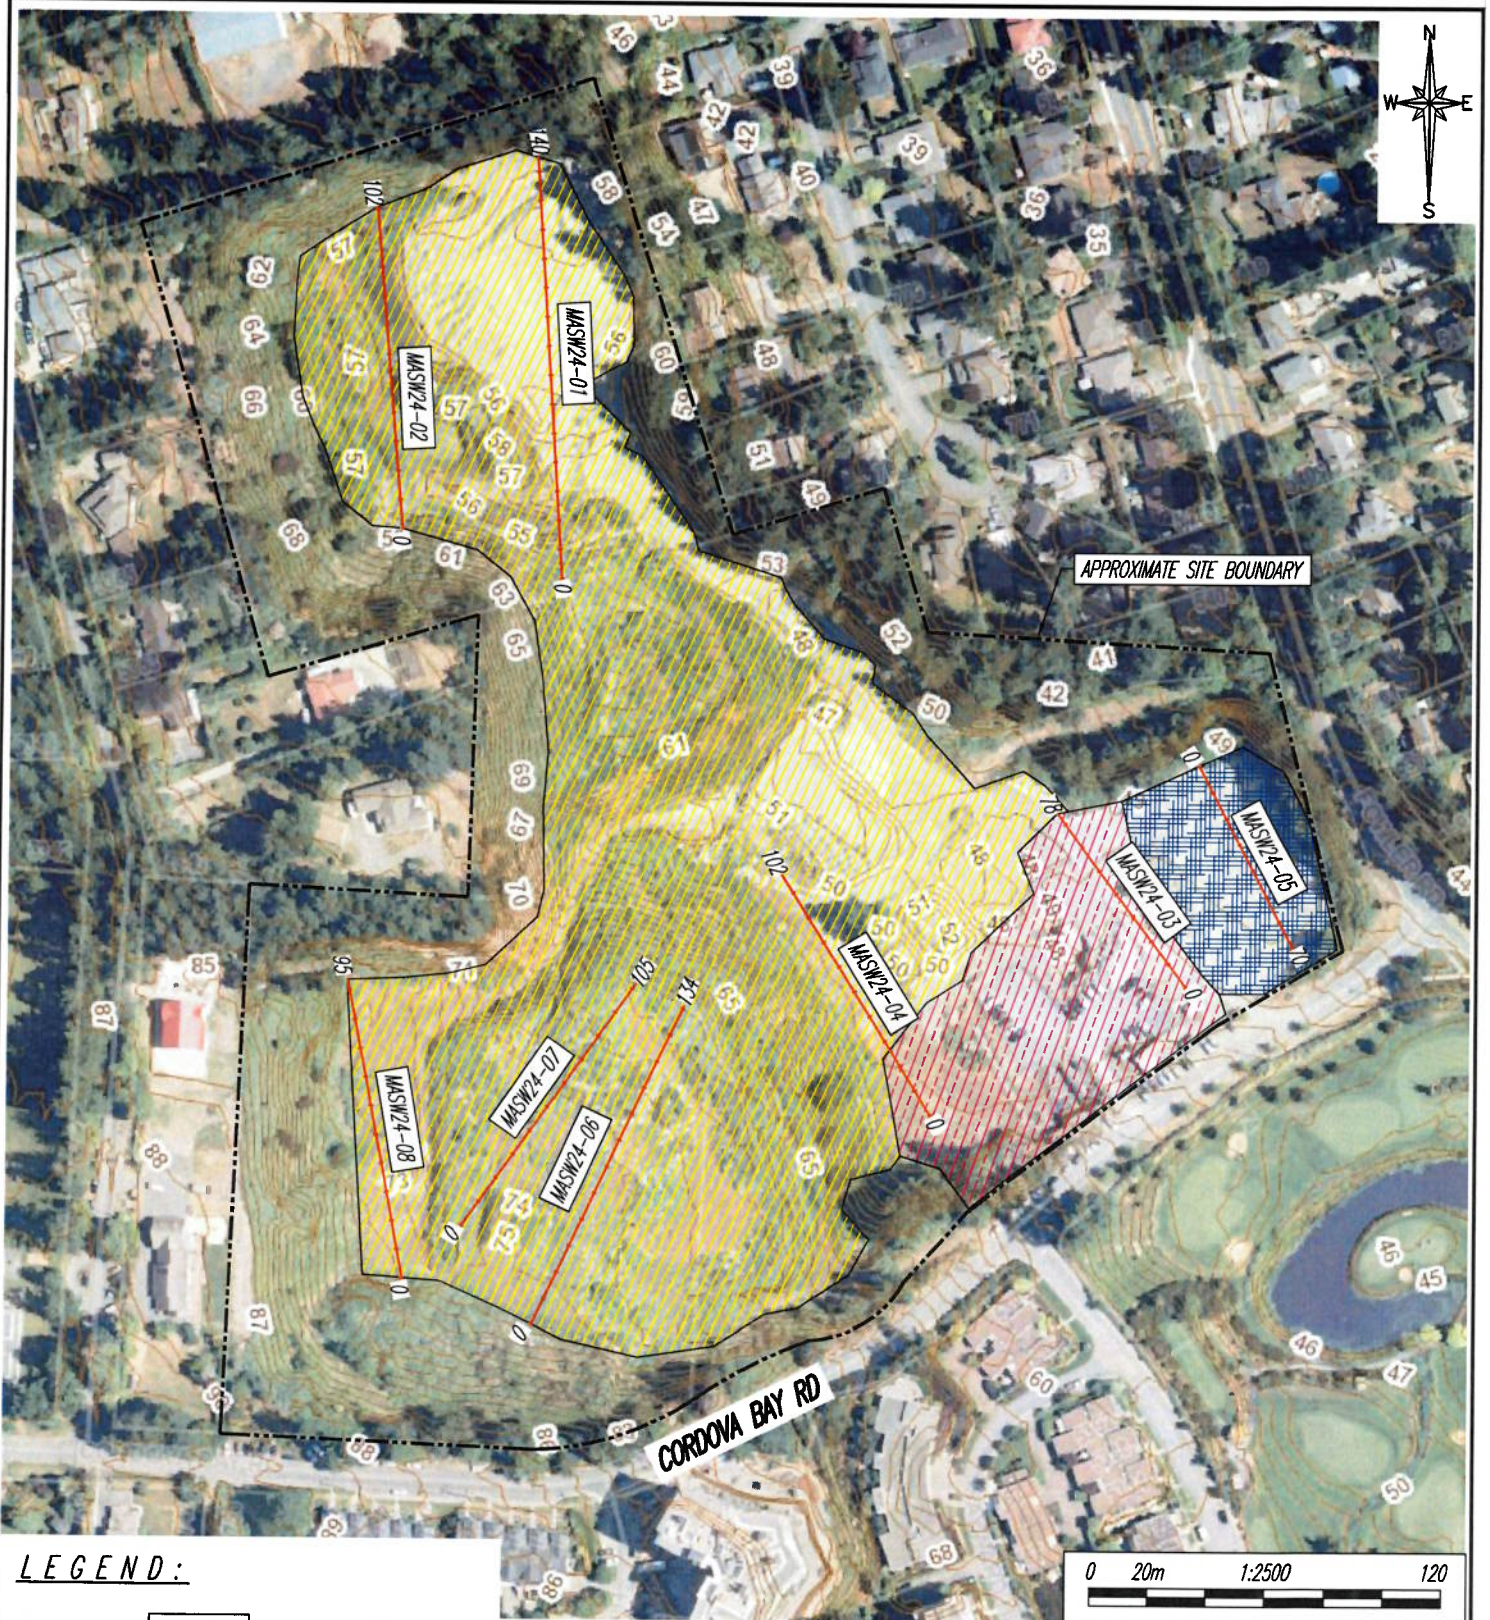
- MASW24-XX - MASW PROFILE
- WASTE FILLS
- SAND OVER GLACIAL TILL
- NORMALLY TO LIGHTLY CONSOLIDATED SILTY CLAY
